# Access Compliance Report

## Public Rights-of-Way

### (Curb Ramps)

Intersection ID: 42486	Main Street: ALEXANDER_MARTIN_AV	Cross Street: ALMA_BLOUNT_BV	Location:	N
ADA ID: 9B4C498DEE47	Ramp Type: Perp	Initial Pass/Fail: Fail	Overall Compliance: No	Severity Score: 33.75

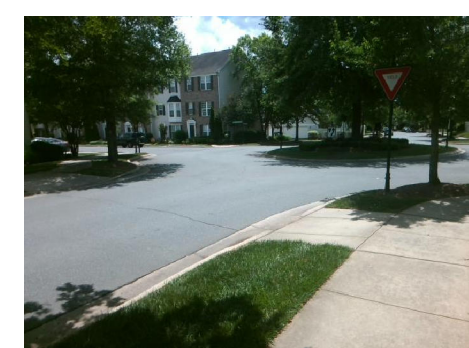
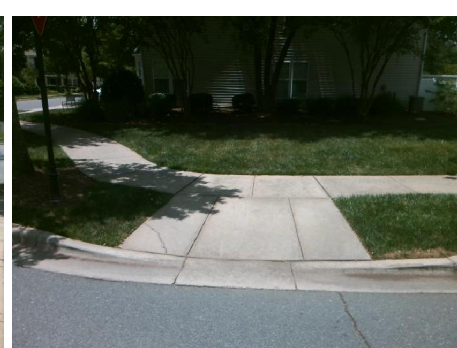
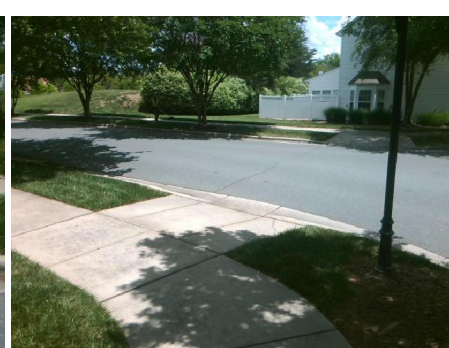
Possible Solutions:		<b>Compliance</b>	<b>Description</b>	<b>Data</b>	<b>Compliance</b>	<b>Description</b>	<b>Data</b>
	<b>Remove &amp; Replace Entire Ramp.</b>		<b>N/A</b>	Ramp Length (in)	<b>72.5</b>	<b>No</b>	Ramp Slope (%)	<b>12.9</b>
			<b>No</b>	Ramp Width (in)	<b>45.5</b>	<b>Yes</b>	Ramp XSlope (%)	<b>0.3</b>
			<b>N/A</b>	Flare Type LT	<b>N/A</b>	<b>N/A</b>	Flare Type RT	<b>N/A</b>
			<b>N/A</b>	Flare Slope LT (%)	<b>N/A</b>	<b>N/A</b>	Flare Slope RT (%)	<b>N/A</b>
			<b>N/A</b>	Flare Traversable LT?	<b>N/A</b>	<b>N/A</b>	Flare Traversable RT?	<b>N/A</b>
			<b>N/A</b>	Landing Length (in)	<b>N/A</b>	<b>N/A</b>	DWS Provided?	<b>N/A</b>
			<b>N/A</b>	Landing Width (in)	<b>N/A</b>	<b>N/A</b>	DWS Contrast?	<b>N/A</b>
			<b>N/A</b>	Landing Slope (%)	<b>N/A</b>	<b>N/A</b>	DWS Length (in)	<b>N/A</b>
			<b>N/A</b>	Landing X Slope (%)	<b>N/A</b>	<b>N/A</b>	DWS Full Width?	<b>N/A</b>

Surveyor Notes:			<b>N/A</b>	Landing Curb? (Y/N)	<b>N/A</b>	<b>N/A</b>	DWS Offset (in)	<b>N/A</b>
PROW/ADA:			<b>N/A</b>	Shared Landing?	<b>N/A</b>			
<b>R304.5.1, R304.2.2</b>			<b>N/A</b>	Gutter Ponding?	<b>N/A</b>	<b>N/A</b>	Gutter Slope (%)	<b>N/A</b>
			<b>N/A</b>	Gutter Lip Ht (in)	<b>N/A</b>	<b>N/A</b>	Gutter X Slope (%)	<b>N/A</b>
			<b>N/A</b>	Painted X Walk1?	<b>No</b>	<b>N/A</b>	Painted X Walk2?	<b>N/A</b>
				X Walk 1 Direction	<b>To SE</b>		X Walk 2 Direction	<b>N/A</b>
			<b>N/A</b>	X Walk 1 Width (in)	<b>N/A</b>	<b>N/A</b>	X Walk 2 Width (in)	<b>N/A</b>
				X Walk 1 Slope (%)	<b>4.3</b>		X Walk 2 Slope (%)	<b>N/A</b>
				X Walk 1 X Slope (%)	<b>0.3</b>		X Walk 2 X Slope (%)	<b>N/A</b>
			<b>N/A</b>	Ramp inside XWalk1?	<b>N/A</b>	<b>N/A</b>	Ramp inside XWalk2?	<b>N/A</b>
				Road Slope (%)	<b>N/A</b>	<b>N/A</b>	Clear Space?	<b>N/A</b>
				Road X Slope (%)	<b>N/A</b>	<b>N/A</b>	Clear Space to XWalk (in)	<b>N/A</b>

<b>N/A</b>	Any Obstructions?	<b>N/A</b>	<b>N/A</b>	Storm Grate/Utility Hazard?	<b>N/A</b>
				Obstruction Type			Storm Grate/Utility Type	
						<b>N/A</b>		<b>N/A</b>
						<b>Yes</b>	Surface Condition? (G/P)	<b>Good</b>
Total Cost:		<b>\$ 1850.00</b>
