Access Compliance Report

Public Rights-of-Way

(Curb Ramps)

Intersection ID: 32317	Main Street: BRIDGEVIEW_LN	Cross Street: NEW_PROVIDENCE_LN	Location: E
ADA ID: 9B6225756ABA	Ramp Type: PerpDiag	Initial Pass/Fail: Fail	Overall Compliance: No
		Severity Score: 37.5

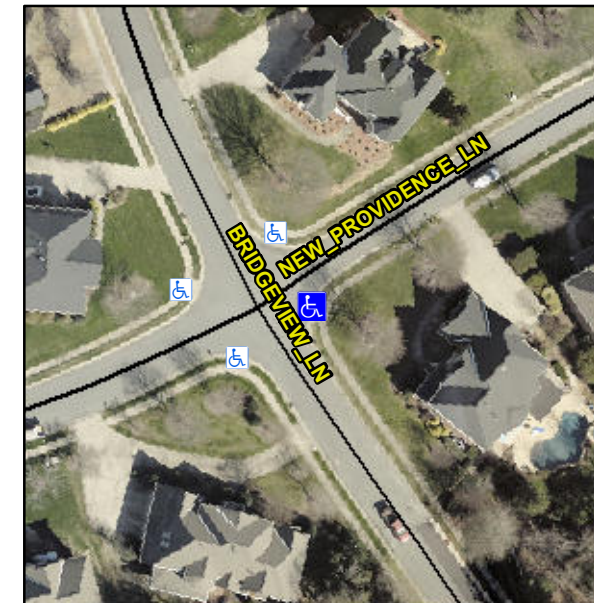
Not Found, R304.2.2, R304.5.3

Compliance	Description	Data	Compliance	Description	Data
N/A	Ramp Length (in)	46.5	No	Ramp Slope (%)	8.7
Yes	Ramp Width (in)	48.0	No	Ramp XSlope (%)	9.0
N/A	Flare Type LT	N/A	N/A	Flare Type RT	N/A
N/A	Flare Slope LT (%)	N/A	N/A	Flare Slope RT (%)	N/A
N/A	Flare Traversable LT?	N/A	N/A	Flare Traversable RT?	N/A
N/A	Landing Length (in)	N/A	N/A	DWS Provided?	N/A
N/A	Landing Width (in)	N/A	N/A	DWS Contrast?	N/A
N/A	Landing Slope (%)	N/A	N/A	DWS Length (in)	N/A
N/A	Landing X Slope (%)	N/A	N/A	DWS Full Width?	N/A
N/A	Landing Curb? (Y/N)	N/A	N/A	DWS Offset (in)	N/A
N/A	Shared Landing?	N/A			
N/A	Gutter Ponding?	N/A	N/A	Gutter Slope (%)	N/A
N/A	Gutter Lip Ht (in)	N/A	N/A	Gutter X Slope (%)	N/A
N/A	Painted X Walk1?	No	N/A	Painted X Walk2?	No
	X Walk 1 Direction	To NW		X Walk 2 Direction	To SW
N/A	X Walk 1 Width (in)	N/A	N/A	X Walk 2 Width (in)	N/A
	X Walk 1 Slope (%)	5.5		X Walk 2 Slope (%)	0.9
	X Walk 1 X Slope (%)	2.6		X Walk 2 X Slope (%)	7.4

N/A	Ramp inside XWalk1?	N/A	N/A	Ramp inside XWalk2?	N/A
	Road Slope (%)	6.4	N/A	Clear Space?	N/A
	Road X Slope (%)	4.2	N/A	Clear Space to XWalk (in)	N/A
N/A	Any Obstructions?	N/A	N/A	Storm Grate/Utility Hazard?	N/A
	Obstruction Type			Storm Grate/Utility Type	
		N/A			N/A
		Yes		Surface Condition? (G/P)	Good

Remove & Replace Curb Ramp With Two New Directional Ramps or Equivalent.
