# Access Compliance Report

## Public Rights-of-Way

### (Curb Ramps)

| Intersection ID: N/A | Main Street: HOOVER_CREEK_BV | Cross Street: WALKER_BRANCH_DR | Location: S |

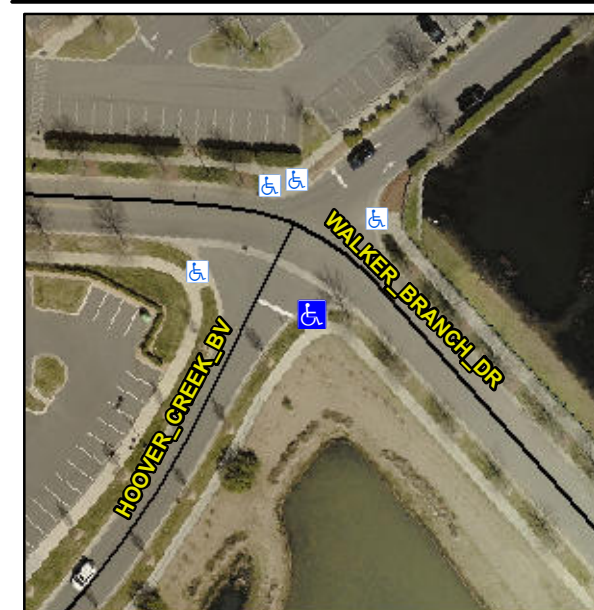
| Severity Score: 12.5 | | | |

**Not Found, R304.5.3**

| Compliance | Description | Data | Compliance | Description | Data |
|---|---|---|---|---|---|
| Yes | Ramp Width (in) | 48.0 | No | Ramp XSlope (%) | 5.4 |

**Remove & Replace Curb Ramp With Two New Directional Ramps or Equivalent.**

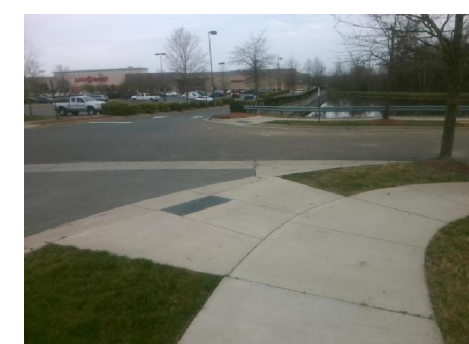
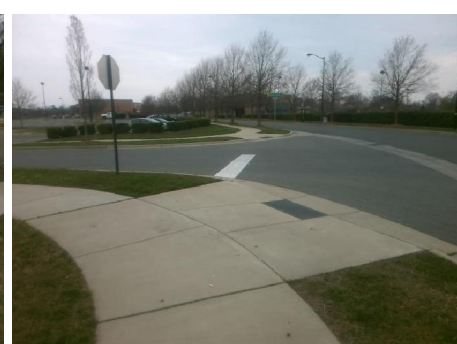
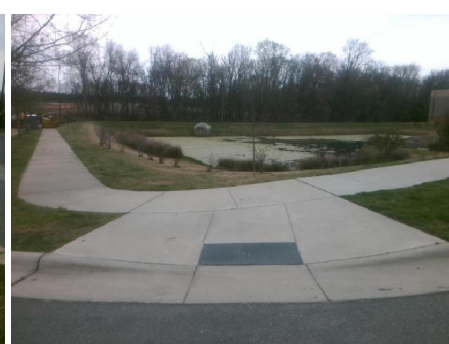
| Compliance | Description | Data | Compliance | Description | Data |
|---|---|---|---|---|---|
| | | Yes | | Surface Condition? (G/P) | Good |
