Access Compliance Report

Public Rights-of-Way

(Curb Ramps)

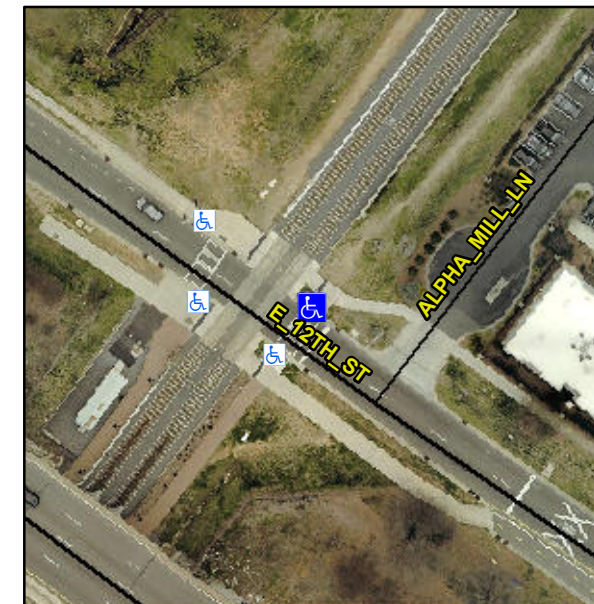
Intersection ID: 48173	Main Street: E_12TH_ST	Cross Street: ALPHA_MILL_LN	Location:	N
ADA ID: 9B6268532BB1	Ramp Type: Perp	Initial Pass/Fail: Pass	Overall Compliance: No	Severity Score: 5
Codes/Mitigation Info/Possible Solution		Field Measurements/Component Compliance

Compliance	Description	Data	Compliance	Description	Data
N/A	Ramp Length (in)	95.0	Yes	Ramp Slope (%)	7.2
Yes	Ramp Width (in)	119.0	Yes	Ramp XSlope (%)	0.1
Yes	Flare Type L	Curbed_NoWalkSurface	Yes	Flare Type RT	N/A
Yes	Flare Slope LT (%)	N/A	N/A	Flare Slope RT (%)	N/A
N/A	Flare Traversable LT?	No	N/A	Flare Traversable RT?	No
Yes	Landing Length (in)	98.0	Yes	DWS Provided?	Yes
Yes	Landing Width (in)	119.0	Yes	DWS Contrast?	Yes
Yes	Landing Slope (%)	0.7	Yes	DWS Length (in)	24.0
Yes	Landing X Slope (%)	0.1	Yes	DWS Full Width?	Yes
N/A	Landing Curb? (Y/N)	No	Yes	DWS Offset (in)	0.0
N/A	Shared Landing?	No			
Yes	Gutter Ponding?	No	No	Gutter Slope (%)	6.3
Yes	Gutter Lip Ht (in)	0.0	No	Gutter X Slope (%)	2.1
N/A	Painted X Walk1?	Yes	N/A	Painted X Walk2?	N/A
	X Walk 1 Direction	To SW		X Walk 2 Direction	N/A
N/A	X Walk 1 Width (in)	104.0	N/A	X Walk 2 Width (in)	N/A
	X Walk 1 Slope (%)	0.1		X Walk 2 Slope (%)	N/A
	X Walk 1 X Slope (%)	1.2		X Walk 2 X Slope (%)	N/A

Yes	Ramp inside XWalk1?	Yes	N/A	Ramp inside XWalk2?	N/A
	Road Slope (%)	N/A	N/A	Clear Space?	Yes
	Road X Slope (%)	N/A	N/A	Clear Space to XWalk (in)	N/A
Yes	Any Obstructions?	No	Yes	Storm Grate/Utility Hazard?	No
	Obstruction Type			Storm Grate/Utility Type	
		N/A			N/A
			Yes	Surface Condition? (G/P)	Good

Possible Solutions:

Remove & Replace Gutter.

R304.5.4, R304.5.3

\$ 750.00
