Access Compliance Report Public Rights-of-Way (Curb Ramps)

Intersection ID: N/A Main Street: MCKEE RD **Cross Street: SISKEY PY** Location: NW **Overall Compliance: No** ADA ID: 9B6B0C1D5EBB Ramp Type: PerpDiag Initial Pass/Fail: Fail Severity Score: 21.25

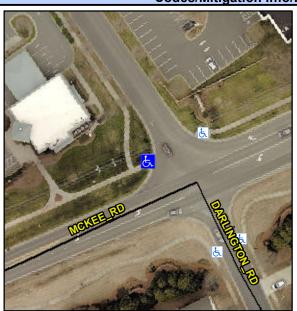
Comp	liance Description	Data	Comp	liance Description	Data
N/A	Ramp Length (in)	64.0	No	Ramp Slope (%)	8.6
No	Ramp Width (in)	46.0	Yes	Ramp XSlope (%)	2.0
N/A	Flare Type LT	N/A	N/A	Flare Type RT	N/A
N/A	Flare Slope LT (%)	N/A	N/A	Flare Slope RT (%)	N/A
N/A	Flare Traversable LT?	N/A	N/A	Flare Traversable RT?	N/A
N/A	Landing Length (in)	N/A	N/A	DWS Provided?	N/A
N/A	Landing Width (in)	N/A	N/A	DWS Contrast?	N/A
N/A	Landing Slope (%)	N/A	N/A	DWS Length (in)	N/A
N/A	Landing X Slope (%)	N/A	N/A	DWS Full Width?	N/A
N/A	Landing Curb? (Y/N)	N/A	N/A	DWS Offset (in)	N/A
N/A	Shared Landing?	N/A			
N/A	Gutter Ponding?	N/A	N/A	Gutter Slope (%)	N/A
N/A	Gutter Lip Ht (in)	N/A	N/A	Gutter X Slope (%)	N/A
N/A	Painted X Walk1?	No	N/A	Painted X Walk2?	No
	X Walk 1 Direction	To SE		X Walk 2 Direction	To NE
N/A	X Walk 1 Width (in)	N/A	N/A	X Walk 2 Width (in)	N/A
	X Walk 1 Slope (%)	0.1		X Walk 2 Slope (%)	1.0
	X Walk 1 X Slope (%)	2.0		X Walk 2 X Slope (%)	1.8

N/A	Ramp inside XWalk1?	N/A	N/A	Ramp inside XWalk2?	N/A
	Road Slope (%)	2.3	N/A	Clear Space?	N/A
	Road X Slope (%)	0.6	N/A	Clear Space to XWalk (in)	N/A
N/A	Any Obstructions?	N/A	N/A	Storm Grate/Utility Hazard?	N/A
	Obstruction Type			Storm Grate/Utility Type	
		N/A			N/A
			Yes	Surface Condition? (G/P)	Good
	+

Street 1 Name MCKEE RD Stop Condition-Street 2 Street 2 Name SISKEY PY Stop Condition-Street 1 StopSign Possible Solutions: Remove & Replace Curb Ramp With **Two New Directional Ramps or** Equivalent.
