# Access Compliance Report

## Public Rights-of-Way

### (Curb Ramps)

Intersection ID: 10029698	Main Street: KINGSTON_FOREST_DR	Cross Street: N/A	Location: NE
ADA ID: 9B6E2261D13F	Ramp Type: BlendTrans1	Initial Pass/Fail: Fail	Overall Compliance: No
Codes/Mitigation Info/Possible Solution		Field Measurements/Component Compliance	
Severity Score: 8.75

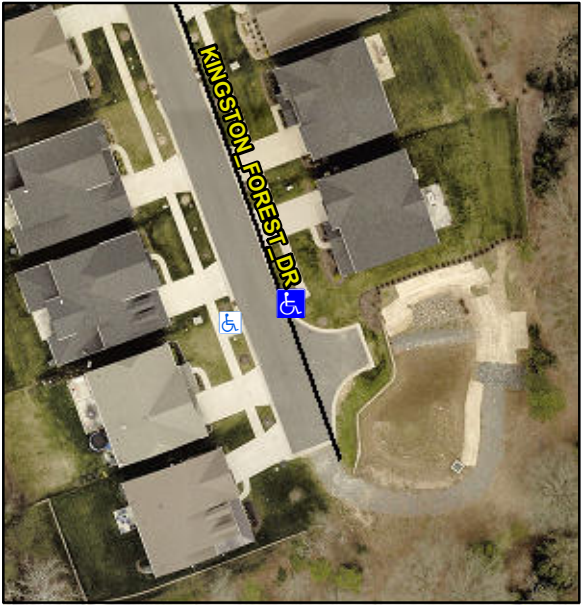
Possible Solutions:	Compliance	Description	Data	Compliance	Description	Data
	Remove & Replace Curb Ramp With Two New Directional Ramps or Equivalent.	N/A	Ramp Length (in)	93.0	Yes	BlendTrans Slope (%)	4.3
		No	Ramp Width (in)	39.0	Yes	BlendTrans XSlope (%)	1.6
		N/A	Flare Type LT	N/A	N/A	Flare Type RT	N/A
		N/A	Flare Slope LT (%)	N/A	N/A	Flare Slope RT (%)	N/A
		N/A	Flare Traversable LT?	N/A	N/A	Flare Traversable RT?	N/A
		N/A	Landing Length (in)	N/A	N/A	DWS Provided?	N/A
		N/A	Landing Width (in)	N/A	N/A	DWS Contrast?	N/A
		N/A	Landing Slope (%)	N/A	N/A	DWS Length (in)	N/A
		N/A	Landing X Slope (%)	N/A	N/A	DWS Full Width?	N/A
<p>Surveyor Notes:</p> <p>N/A</p> <p>PROW/ADA:</p> <p>Not Found, R304.5.1</p>		N/A	Landing Curb? (Y/N)	N/A	N/A	DWS Offset (in)	N/A
		N/A	Shared Landing?	N/A			
		N/A	Gutter Ponding?	Yes	N/A	Gutter Slope (%)	N/A
		N/A	Gutter Lip Ht (in)	N/A	N/A	Gutter X Slope (%)	N/A
		N/A	Painted X Walk1?	No	N/A	Painted X Walk2?	N/A

X Walk 1 Direction	To SW		X Walk 2 Direction	N/A
			X Walk 1 Width (in)	N/A		X Walk 2 Width (in)	N/A
			X Walk 1 Slope (%)	4.3		X Walk 2 Slope (%)	N/A
			X Walk 1 X Slope (%)	1.5		X Walk 2 X Slope (%)	N/A
		N/A	Ramp inside XWalk1?	N/A	N/A	Ramp inside XWalk2?	N/A
<p>Street 1 Name</p> <p>Stop Condition-Street 1</p> <p>Street 2 Name</p> <p>Stop Condition-Street 2</p>			Road Slope (%)	1.5		Clear Space?	N/A
			Road X Slope (%)	4.3	N/A	Clear Space to XWalk (in)	N/A
		N/A	Any Obstructions?	N/A	N/A	Storm Grate/Utility Hazard?	N/A
			Obstruction Type			Storm Grate/Utility Type	
					N/A		N/A
					Yes	Surface Condition? (G/P)	Good
					No	Curb Slope (%)	8.4
Total Cost:		\$	3200.00
