## Access Compliance Report Public Rights-of-Way (Curb Ramps)

Intersection ID: 27747 Main Street: HANLIN\_CT Cross Street: LANSFORD\_RD Location: SW

ADA ID: 9B6FE368D124 Ramp Type: PerpDiag Initial Pass/Fail: Fail Overall Compliance: No Severity Score: 8.75

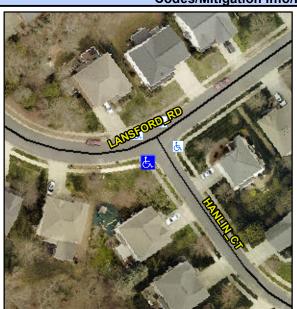
No

HANLIN CT StopSign LANSFORD RD None Possible Solutions:

Remove & Replace Curb Ramp With Two New Directional Ramps or Equivalent.

PROW/ADA:
R304.5.1

Total Cost: \$ 3200.00
