Access Compliance Report

Public Rights-of-Way

(Curb Ramps)

| Intersection ID: 22863 | Main Street: ARBOR_RIDGE_DR | Cross Street: CEDAR_CROSSINGS_DR | Location: SW |

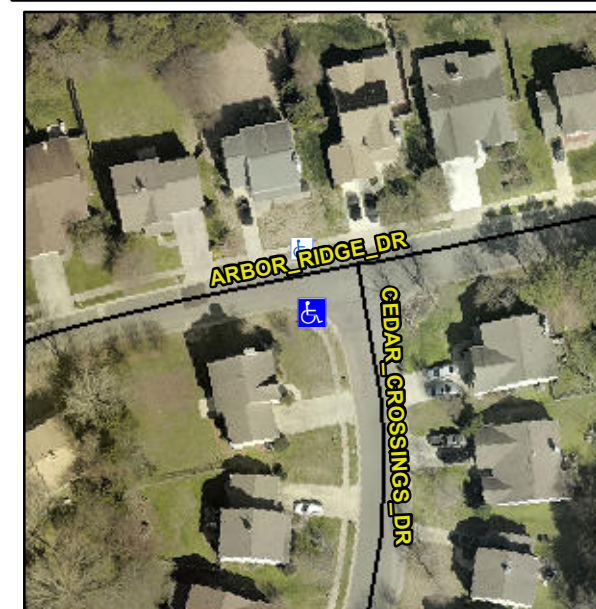
Not Found, R304.2.1, R304.2.2-Perp, R304.3.2-Para, R304.5.3, R305

| Compliance | Description | Data | Compliance | Description | Data |
|---|---|---|---|---|---|
| No | Landing Length (in) | N/A | No | DWS Provided? | No |
| No | Landing Width (in) | N/A | N/A | DWS Contrast? | No |
| No | Landing Slope (%) | N/A | N/A | DWS Length (in) | N/A |
| No | Landing X Slope (%) | N/A | N/A | DWS Full Width? | No |

Remove & Replace Curb Ramp With Two New Directional Ramps or Equivalent.
