Access Compliance Report

Public Rights-of-Way (Curb Ramps)

Intersection ID: 24329	Main Street: GARBOW_CT	Cross Street: MIROW_PL	Location: S
ADA ID: 9B7876058CE0	Ramp Type: PerpDiag	Initial Pass/Fail: Fail	Overall Compliance: No
		Severity Score: 25

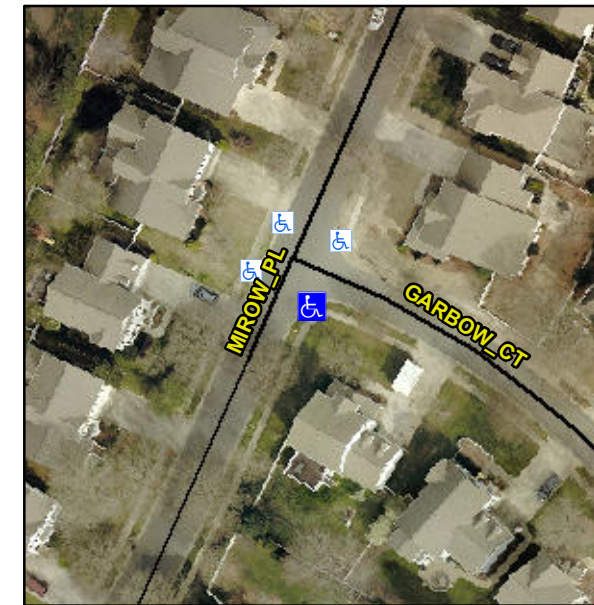
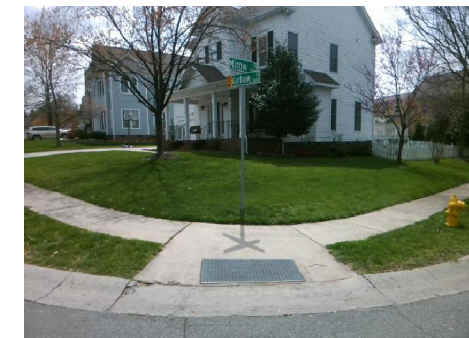
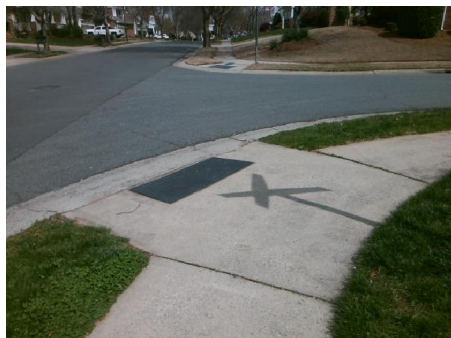
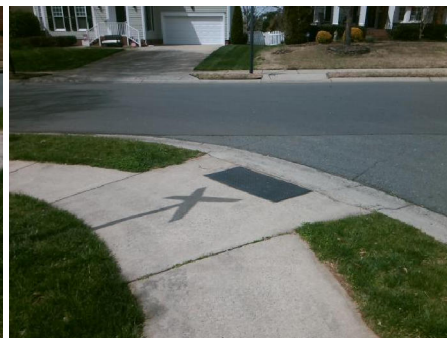
Not Found, R304.2.2, R304.5.3

Compliance	Description	Data	Compliance	Description	Data
N/A	Ramp Length (in)	37.0	No	Ramp Slope (%)	8.4
Yes	Ramp Width (in)	48.0	No	Ramp XSlope (%)	5.4
N/A	Flare Type LT	N/A	N/A	Flare Type RT	N/A
N/A	Flare Slope LT (%)	N/A	N/A	Flare Slope RT (%)	N/A
N/A	Flare Traversable LT?	N/A	N/A	Flare Traversable RT?	N/A
N/A	Landing Length (in)	N/A	N/A	DWS Provided?	N/A
N/A	Landing Width (in)	N/A	N/A	DWS Contrast?	N/A
N/A	Landing Slope (%)	N/A	N/A	DWS Length (in)	N/A
N/A	Landing X Slope (%)	N/A	N/A	DWS Full Width?	N/A
N/A	Landing Curb? (Y/N)	N/A	N/A	DWS Offset (in)	N/A
N/A	Shared Landing?	N/A			
N/A	Gutter Ponding?	N/A	N/A	Gutter Slope (%)	N/A
N/A	Gutter Lip Ht (in)	N/A	N/A	Gutter X Slope (%)	N/A
N/A	Painted X Walk1?	No	N/A	Painted X Walk2?	No
	X Walk 1 Direction	To NE		X Walk 2 Direction	To NW
N/A	X Walk 1 Width (in)	N/A	N/A	X Walk 2 Width (in)	N/A
	X Walk 1 Slope (%)	5.5		X Walk 2 Slope (%)	1.2
	X Walk 1 X Slope (%)	1.5		X Walk 2 X Slope (%)	4.0

N/A	Ramp inside XWalk1?	N/A	N/A	Ramp inside XWalk2?	N/A
	Road Slope (%)	2.9	N/A	Clear Space?	N/A
	Road X Slope (%)	3.7	N/A	Clear Space to XWalk (in)	N/A
N/A	Any Obstructions?	N/A	N/A	Storm Grate/Utility Hazard?	N/A
	Obstruction Type			Storm Grate/Utility Type	
		N/A			N/A
		Yes		Surface Condition? (G/P)	Good

Remove & Replace Curb Ramp With Two New Directional Ramps or Equivalent.
