Access Compliance Report

Public Rights-of-Way

(Curb Ramps)

Intersection ID: N/A	Main Street: HALKIRK_MANOR_LN	Cross Street: KIRKWYND_COMMONS_DR	Location: NE
ADA ID: 9B84A1794DDF	Ramp Type: PerpDiag	Initial Pass/Fail: Fail	Overall Compliance: No
Codes/Mitigation Info/Possible Solution		Field Measurements/Component Compliance

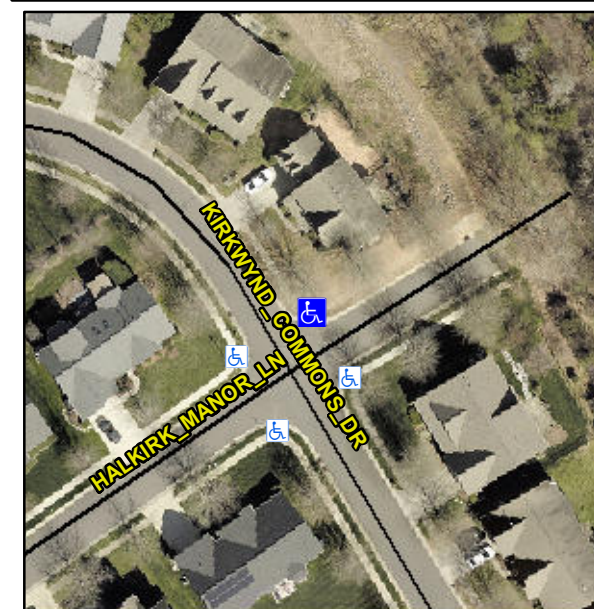
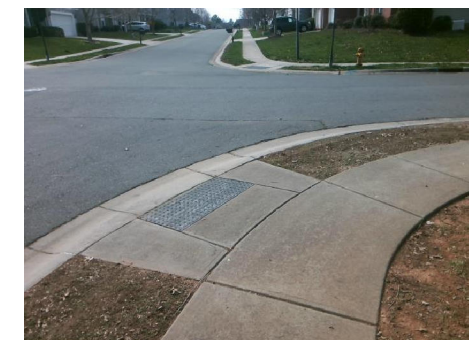
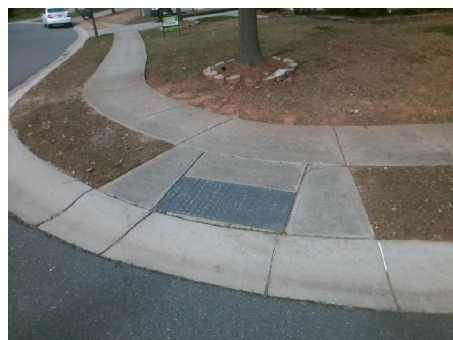
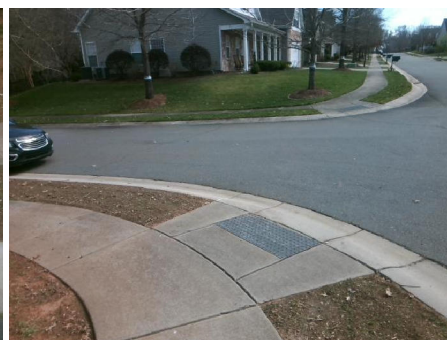
Not Found, R304.5.1

Compliance	Description	Data	Compliance	Description	Data
N/A	Ramp Length (in)	47.0	Yes	Ramp Slope (%)	5.7
No	Ramp Width (in)	46.0	Yes	Ramp XSlope (%)	2.2
N/A	Flare Type LT	N/A	N/A	Flare Type RT	N/A
N/A	Flare Slope LT (%)	N/A	N/A	Flare Slope RT (%)	N/A
N/A	Flare Traversable LT?	N/A	N/A	Flare Traversable RT?	N/A
N/A	Landing Length (in)	N/A	N/A	DWS Provided?	N/A
N/A	Landing Width (in)	N/A	N/A	DWS Contrast?	N/A
N/A	Landing Slope (%)	N/A	N/A	DWS Length (in)	N/A
N/A	Landing X Slope (%)	N/A	N/A	DWS Full Width?	N/A
N/A	Landing Curb? (Y/N)	N/A	N/A	DWS Offset (in)	N/A
N/A	Shared Landing?	N/A			
N/A	Gutter Ponding?	N/A	N/A	Gutter Slope (%)	N/A
N/A	Gutter Lip Ht (in)	N/A	N/A	Gutter X Slope (%)	N/A
N/A	Painted X Walk1?	No	N/A	Painted X Walk2?	No
	X Walk 1 Direction	To SW		X Walk 2 Direction	To SE
N/A	X Walk 1 Width (in)	N/A	N/A	X Walk 2 Width (in)	N/A
	X Walk 1 Slope (%)	7.3		X Walk 2 Slope (%)	4.9
	X Walk 1 X Slope (%)	1.4		X Walk 2 X Slope (%)	4.1

N/A	Ramp inside XWalk1?	N/A	N/A	Ramp inside XWalk2?	N/A
	Road Slope (%)	2.6	N/A	Clear Space?	N/A
	Road X Slope (%)	6.0	N/A	Clear Space to XWalk (in)	N/A
N/A	Any Obstructions?	N/A	N/A	Storm Grate/Utility Hazard?	N/A
	Obstruction Type			Storm Grate/Utility Type	
		N/A			N/A
			Yes	Surface Condition? (G/P)	Good

Remove & Replace Curb Ramp With Two New Directional Ramps or Equivalent.
