# Access Compliance Report

## Public Rights-of-Way

### (Curb Ramps)

| Intersection ID: 54154 | Main Street: DEWEY_CREEK_LN | Cross Street: MAPLE_CREEK_CT | Location: NE |

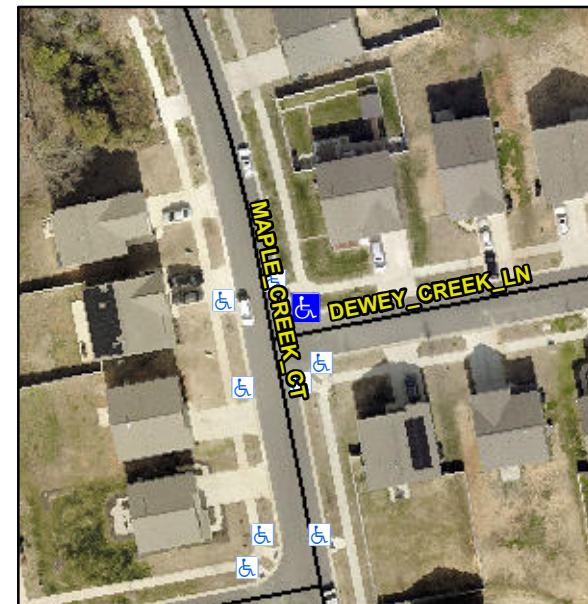
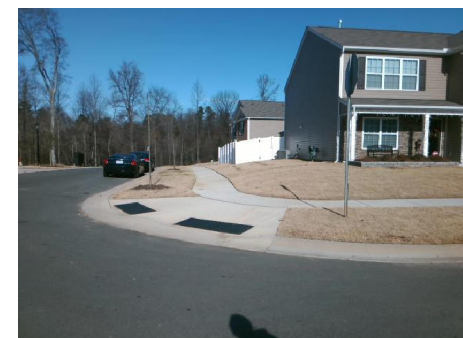
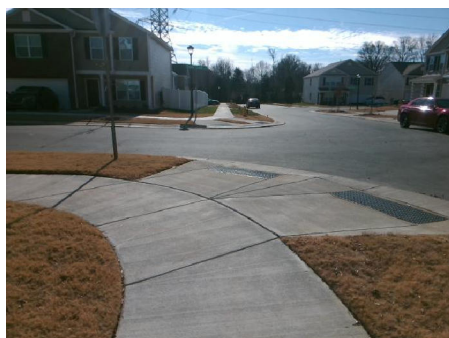
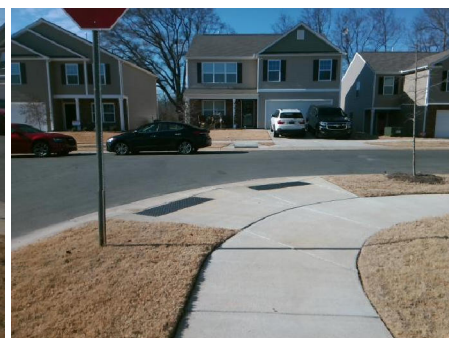
| ADA ID: 9B9076CF008E | Ramp Type: Perp | Initial Pass/Fail: Pass | Overall Compliance: No |

**R305.2, R302.7.2, R304.5.3**

| Compliance | Description | Data | Compliance | Description | Data |
|---|---|---|---|---|---|
| N/A | Landing Curb? (Y/N) | No | No | DWS Offset (in) | 3.5 |
| No | Gutter Lip Ht (in) | 1.5 | No | Gutter X Slope (%) | 2.5 |

**Remove & Replace Detectable Warning System. Remove & Replace Gutter.**
