# Access Compliance Report

## Public Rights-of-Way

### (Curb Ramps)

Intersection ID: 9560	Main Street: LUCKY_PENNY_ST	Cross Street: FREEDOM_DR	Location: NW
ADA ID: 9B9B062834F3	Ramp Type: Perp	Initial Pass/Fail: Fail	Overall Compliance: No
Severity Score: 46.25			
Codes/Mitigation Info/Possible Solution		Field Measurements/Component Compliance

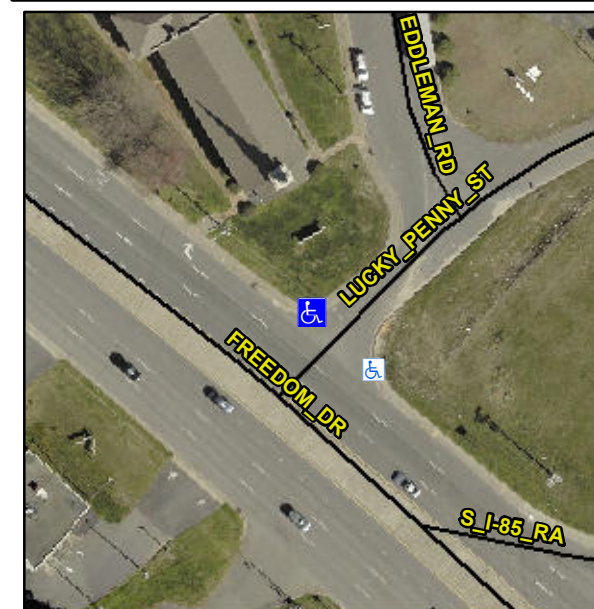
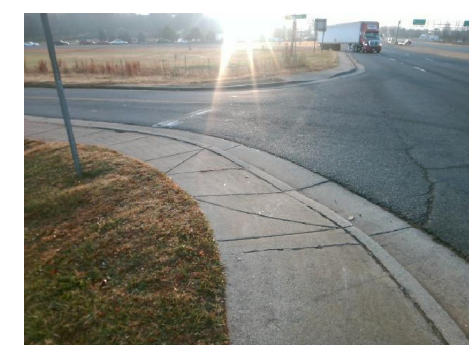
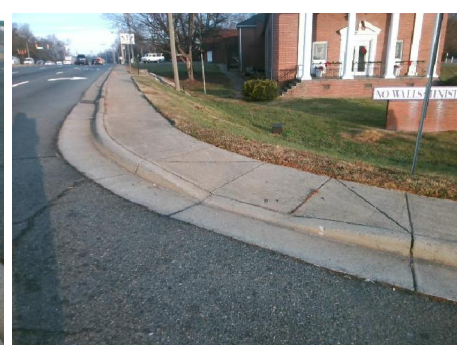
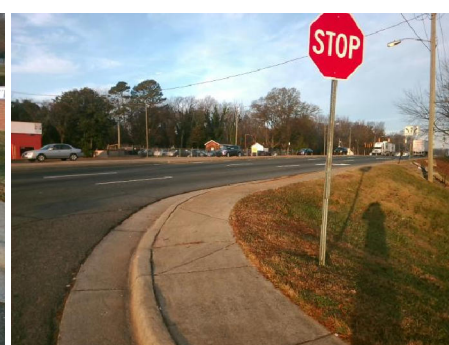
**Not Found, R304.5.1, R304.2.2, R304.5.3**

Compliance	Description	Data	Compliance	Description	Data
N/A	Ramp Length (in)	47.0	No	Ramp Slope (%)	10.5
No	Ramp Width (in)	37.5	No	Ramp XSlope (%)	8.9
N/A	Flare Type LT	N/A	N/A	Flare Type RT	N/A
N/A	Flare Slope LT (%)	N/A	N/A	Flare Slope RT (%)	N/A
N/A	Flare Traversable LT?	N/A	N/A	Flare Traversable RT?	N/A
N/A	Landing Length (in)	N/A	N/A	DWS Provided?	N/A
N/A	Landing Width (in)	N/A	N/A	DWS Contrast?	N/A
N/A	Landing Slope (%)	N/A	N/A	DWS Length (in)	N/A
N/A	Landing X Slope (%)	N/A	N/A	DWS Full Width?	N/A
N/A	Landing Curb? (Y/N)	N/A	N/A	DWS Offset (in)	N/A
N/A	Shared Landing?	N/A			
N/A	Gutter Ponding?	N/A	N/A	Gutter Slope (%)	N/A
N/A	Gutter Lip Ht (in)	N/A	N/A	Gutter X Slope (%)	N/A
N/A	Painted X Walk1?	No	N/A	Painted X Walk2?	N/A
	X Walk 1 Direction	To SE		X Walk 2 Direction	N/A
N/A	X Walk 1 Width (in)	N/A	N/A	X Walk 2 Width (in)	N/A
	X Walk 1 Slope (%)	3.1		X Walk 2 Slope (%)	N/A
	X Walk 1 X Slope (%)	8.6		X Walk 2 X Slope (%)	N/A

N/A	Ramp inside XWalk1?	N/A	N/A	Ramp inside XWalk2?	N/A
	Road Slope (%)	N/A	N/A	Clear Space?	N/A
	Road X Slope (%)	N/A	N/A	Clear Space to XWalk (in)	N/A
N/A	Any Obstructions?	N/A	N/A	Storm Grate/Utility Hazard?	N/A
	Obstruction Type			Storm Grate/Utility Type	
		N/A			N/A
		Yes		Surface Condition? (G/P)	Good

**Remove & Replace Entire Ramp.**
