# Access Compliance Report

## Public Rights-of-Way

### (Curb Ramps)

Intersection ID: 43670	Main Street: S_TRYON_ST	Cross Street: CORSICA_FOREST_DR	Location:	N
ADA ID: 9BA081D34A8A	Ramp Type: Perp	Initial Pass/Fail: Fail	Overall Compliance: No	Severity Score: 25

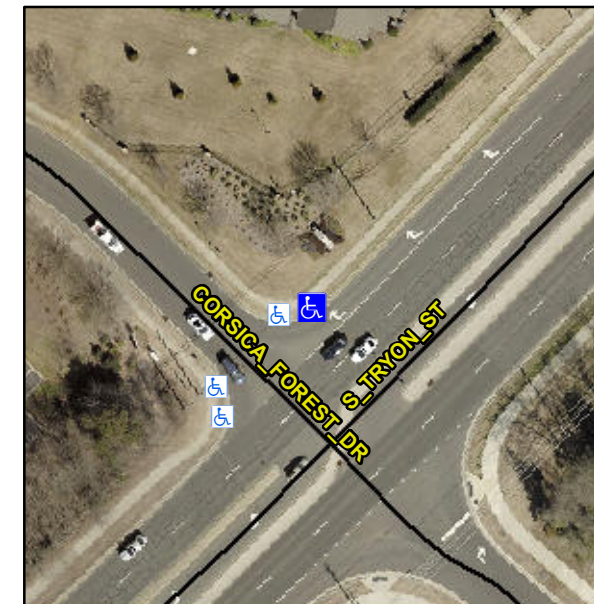
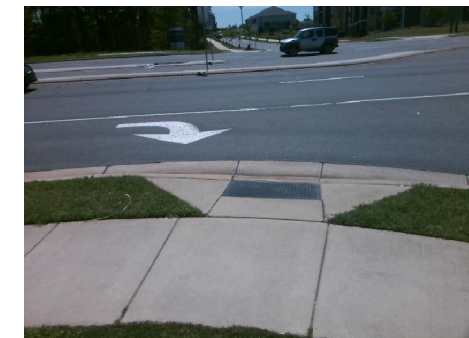
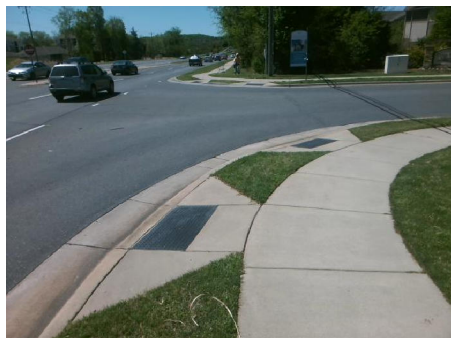
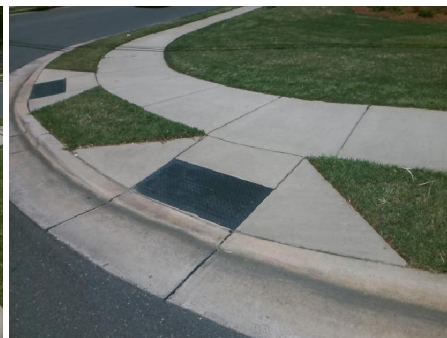
Compliance	Description	Data	Compliance	Description	Data
N/A	Ramp Length (in)	47.0	No	Ramp Slope (%)	10.2
Yes	Ramp Width (in)	48.0	No	Ramp XSlope (%)	5.4
N/A	Flare Type LT	N/A	N/A	Flare Type RT	N/A
N/A	Flare Slope LT (%)	N/A	N/A	Flare Slope RT (%)	N/A
N/A	Flare Traversable LT?	N/A	N/A	Flare Traversable RT?	N/A
N/A	Landing Length (in)	N/A	N/A	DWS Provided?	N/A
N/A	Landing Width (in)	N/A	N/A	DWS Contrast?	N/A
N/A	Landing Slope (%)	N/A	N/A	DWS Length (in)	N/A
N/A	Landing X Slope (%)	N/A	N/A	DWS Full Width?	N/A
N/A	Landing Curb? (Y/N)	N/A	N/A	DWS Offset (in)	N/A
N/A	Shared Landing?	N/A			
N/A	Gutter Ponding?	N/A	N/A	Gutter Slope (%)	N/A
N/A	Gutter Lip Ht (in)	N/A	N/A	Gutter X Slope (%)	N/A
N/A	Painted X Walk1?	No	N/A	Painted X Walk2?	N/A
	X Walk 1 Direction	To SE		X Walk 2 Direction	N/A
N/A	X Walk 1 Width (in)	N/A	N/A	X Walk 2 Width (in)	N/A
	X Walk 1 Slope (%)	2.0		X Walk 2 Slope (%)	N/A
	X Walk 1 X Slope (%)	4.0		X Walk 2 X Slope (%)	N/A

N/A	Ramp inside XWalk1?	N/A	N/A	Ramp inside XWalk2?	N/A
	Road Slope (%)	N/A	N/A	Clear Space?	N/A
	Road X Slope (%)	N/A	N/A	Clear Space to XWalk (in)	N/A
N/A	Any Obstructions?	N/A	N/A	Storm Grate/Utility Hazard?	N/A
	Obstruction Type			Storm Grate/Utility Type	
		N/A			N/A
			Yes	Surface Condition? (G/P)	Good

**Remove & Replace Entire Ramp.**

**R304.2.2, R304.5.3**
