Access Compliance Report

Public Rights-of-Way

(Curb Ramps)

Intersection ID: 20092	Main Street: DOVES_ROOST_CT	Cross Street: GOVERNORS_HILL_LN	Location: NE
ADA ID: 9BA2028CA337	Ramp Type: PerpDiag	Initial Pass/Fail: Fail	Overall Compliance: No
		Severity Score: 12.5

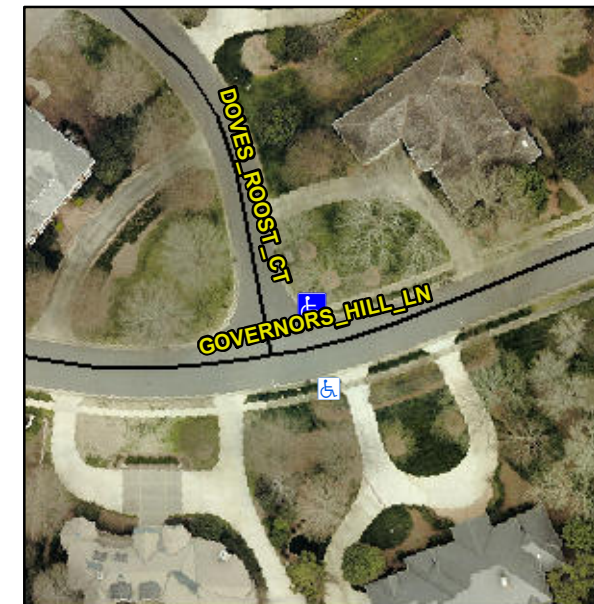
Not Found, R304.2.2

Compliance	Description	Data	Compliance	Description	Data
N/A	Ramp Length (in)	47.0	No	Ramp Slope (%)	9.3
Yes	Ramp Width (in)	48.0	Yes	Ramp XSlope (%)	1.1
N/A	Flare Type LT	N/A	N/A	Flare Type RT	N/A
N/A	Flare Slope LT (%)	N/A	N/A	Flare Slope RT (%)	N/A
N/A	Flare Traversable LT?	N/A	N/A	Flare Traversable RT?	N/A
N/A	Landing Length (in)	N/A	N/A	DWS Provided?	N/A
N/A	Landing Width (in)	N/A	N/A	DWS Contrast?	N/A
N/A	Landing Slope (%)	N/A	N/A	DWS Length (in)	N/A
N/A	Landing X Slope (%)	N/A	N/A	DWS Full Width?	N/A
N/A	Landing Curb? (Y/N)	N/A	N/A	DWS Offset (in)	N/A
N/A	Shared Landing?	N/A			
N/A	Gutter Ponding?	N/A	N/A	Gutter Slope (%)	N/A
N/A	Gutter Lip Ht (in)	N/A	N/A	Gutter X Slope (%)	N/A
N/A	Painted X Walk1?	No	N/A	Painted X Walk2?	No
	X Walk 1 Direction	To W		X Walk 2 Direction	To S
N/A	X Walk 1 Width (in)	N/A	N/A	X Walk 2 Width (in)	N/A
	X Walk 1 Slope (%)	3.2		X Walk 2 Slope (%)	0.3
	X Walk 1 X Slope (%)	0.3		X Walk 2 X Slope (%)	3.0

N/A	Ramp inside XWalk1?	N/A	N/A	Ramp inside XWalk2?	N/A
	Road Slope (%)	1.4	N/A	Clear Space?	N/A
	Road X Slope (%)	3.2	N/A	Clear Space to XWalk (in)	N/A
N/A	Any Obstructions?	N/A	N/A	Storm Grate/Utility Hazard?	N/A
	Obstruction Type			Storm Grate/Utility Type	
		N/A			N/A
			Yes	Surface Condition? (G/P)	Good

Remove & Replace Curb Ramp With Two New Directional Ramps or Equivalent.
