Access Compliance Report

Public Rights-of-Way

(Curb Ramps)

Intersection ID: 3261	Main Street: BILLINGHAM_DR	Cross Street: MCKENDREE_WY	Location: SW
ADA ID: 9BAD22F4A41D	Ramp Type: Perp	Initial Pass/Fail: Fail	Overall Compliance: No
Severity Score: 8.75			
Codes/Mitigation Info/Possible Solution		Field Measurements/Component Compliance

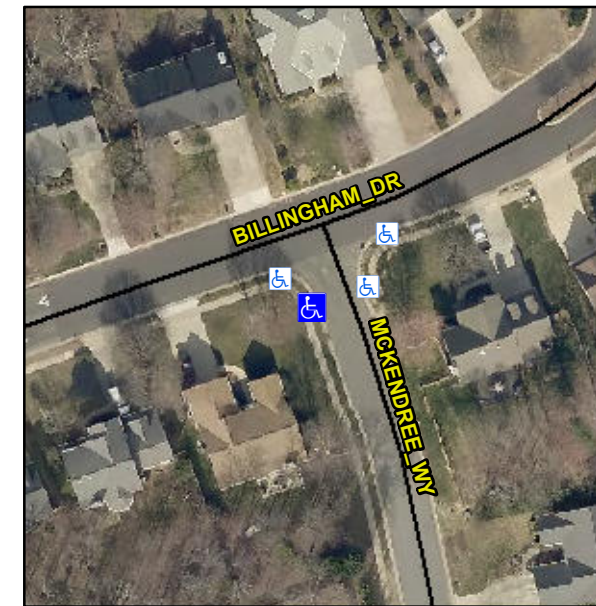
Not Found, R304.5.1

Compliance	Description	Data	Compliance	Description	Data
N/A	Ramp Length (in)	46.0	Yes	Ramp Slope (%)	5.4
No	Ramp Width (in)	46.0	Yes	Ramp XSlope (%)	1.9
N/A	Flare Type LT	N/A	N/A	Flare Type RT	N/A
N/A	Flare Slope LT (%)	N/A	N/A	Flare Slope RT (%)	N/A
N/A	Flare Traversable LT?	N/A	N/A	Flare Traversable RT?	N/A
N/A	Landing Length (in)	N/A	N/A	DWS Provided?	N/A
N/A	Landing Width (in)	N/A	N/A	DWS Contrast?	N/A
N/A	Landing Slope (%)	N/A	N/A	DWS Length (in)	N/A
N/A	Landing X Slope (%)	N/A	N/A	DWS Full Width?	N/A
N/A	Landing Curb? (Y/N)	N/A	N/A	DWS Offset (in)	N/A
N/A	Shared Landing?	N/A			
N/A	Gutter Ponding?	N/A	N/A	Gutter Slope (%)	N/A
N/A	Gutter Lip Ht (in)	N/A	N/A	Gutter X Slope (%)	N/A
N/A	Painted X Walk1?	No	N/A	Painted X Walk2?	N/A
	X Walk 1 Direction	To E		X Walk 2 Direction	N/A
N/A	X Walk 1 Width (in)	N/A	N/A	X Walk 2 Width (in)	N/A
	X Walk 1 Slope (%)	2.4		X Walk 2 Slope (%)	N/A
	X Walk 1 X Slope (%)	0.2		X Walk 2 X Slope (%)	N/A

N/A	Ramp inside XWalk1?	N/A	N/A	Ramp inside XWalk2?	N/A
	Road Slope (%)	N/A	N/A	Clear Space?	N/A
	Road X Slope (%)	N/A	N/A	Clear Space to XWalk (in)	N/A
N/A	Any Obstructions?	N/A	N/A	Storm Grate/Utility Hazard?	N/A
	Obstruction Type			Storm Grate/Utility Type	
		N/A			N/A
		Yes		Surface Condition? (G/P)	Good

Remove & Replace Entire Ramp.

Total Cost: \$ 1850.00
