Access Compliance Report

Public Rights-of-Way

(Curb Ramps)

Intersection ID: N/A	Main Street: WOODRIVER_LN	Cross Street: DOWINGTON_DR	Location: SE
ADA ID: 9BAF594DB56B	Ramp Type: Perp	Initial Pass/Fail: Fail	Overall Compliance: No
Severity Score: 33.75			
Codes/Mitigation Info/Possible Solution		Field Measurements/Component Compliance

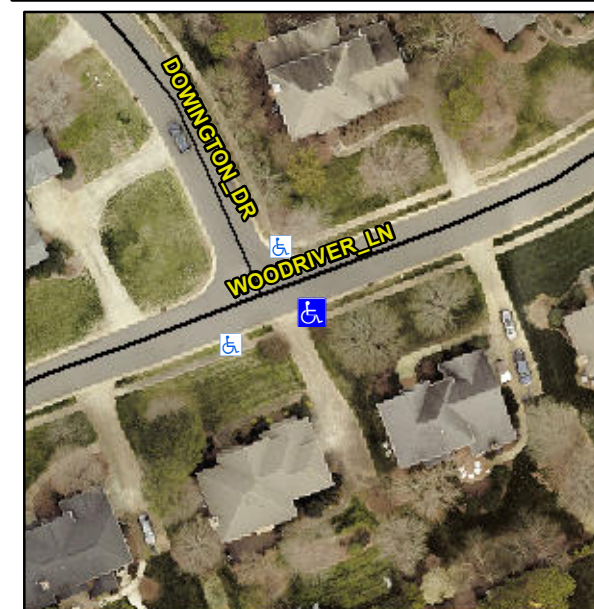
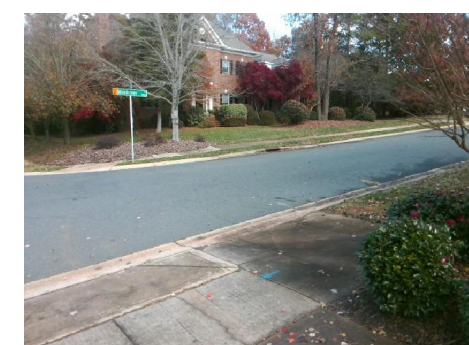
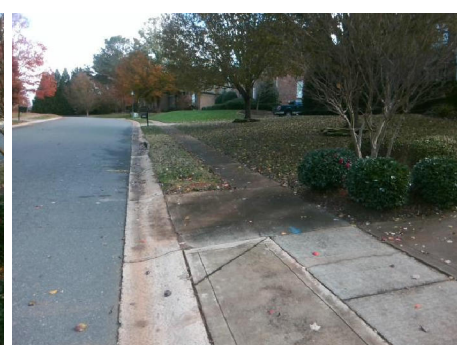
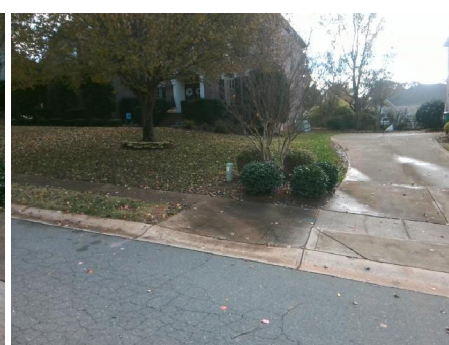
R304.5.1, R304.5.3

Compliance	Description	Data	Compliance	Description	Data
N/A	Ramp Length (in)	96.0	Yes	Ramp Slope (%)	6.1
No	Ramp Width (in)	46.0	No	Ramp XSlope (%)	9.3
N/A	Flare Type LT	N/A	N/A	Flare Type RT	N/A
N/A	Flare Slope LT (%)	N/A	N/A	Flare Slope RT (%)	N/A
N/A	Flare Traversable LT?	N/A	N/A	Flare Traversable RT?	N/A
N/A	Landing Length (in)	N/A	N/A	DWS Provided?	N/A
N/A	Landing Width (in)	N/A	N/A	DWS Contrast?	N/A
N/A	Landing Slope (%)	N/A	N/A	DWS Length (in)	N/A
N/A	Landing X Slope (%)	N/A	N/A	DWS Full Width?	N/A
N/A	Landing Curb? (Y/N)	N/A	N/A	DWS Offset (in)	N/A
N/A	Shared Landing?	N/A			
N/A	Gutter Ponding?	N/A	N/A	Gutter Slope (%)	N/A
N/A	Gutter Lip Ht (in)	N/A	N/A	Gutter X Slope (%)	N/A
N/A	Painted X Walk1?	No	N/A	Painted X Walk2?	N/A
	X Walk 1 Direction	To N		X Walk 2 Direction	N/A
N/A	X Walk 1 Width (in)	N/A	N/A	X Walk 2 Width (in)	N/A
	X Walk 1 Slope (%)	3.5		X Walk 2 Slope (%)	N/A
	X Walk 1 X Slope (%)	8.6		X Walk 2 X Slope (%)	N/A

N/A	Ramp inside XWalk1?	N/A	N/A	Ramp inside XWalk2?	N/A
	Road Slope (%)	N/A	N/A	Clear Space?	N/A
	Road X Slope (%)	N/A	N/A	Clear Space to XWalk (in)	N/A
N/A	Any Obstructions?	N/A	N/A	Storm Grate/Utility Hazard?	N/A
	Obstruction Type			Storm Grate/Utility Type	
		N/A			N/A
			Yes	Surface Condition? (G/P)	Good

Possible Solutions:

Remove & Replace Entire Ramp.
