# Access Compliance Report

## Public Rights-of-Way

### (Curb Ramps)

Intersection ID: 14974	Main Street: CRESCENT_AV	Cross Street: WILLOUGHBY_ST	Location: NW
ADA ID: 9BB21E9C9949	Ramp Type: Perp	Initial Pass/Fail: Fail	Overall Compliance: No
Severity Score: 12.5			
Codes/Mitigation Info/Possible Solution		Field Measurements/Component Compliance

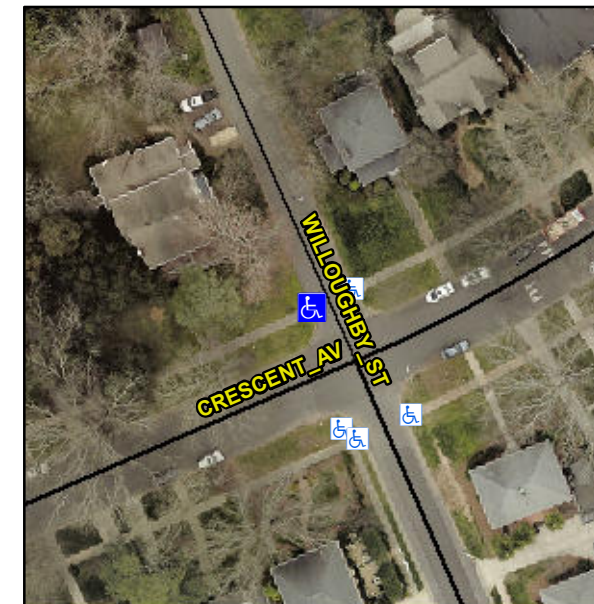
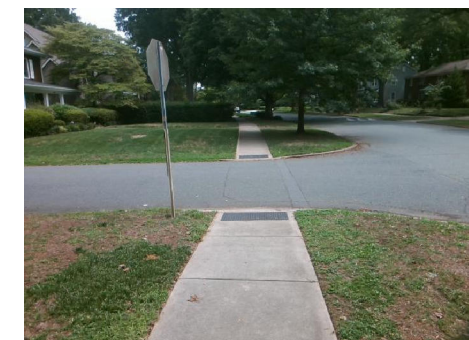
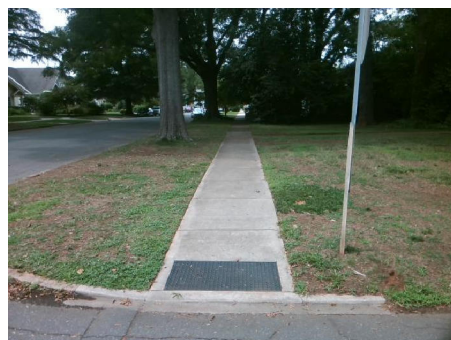
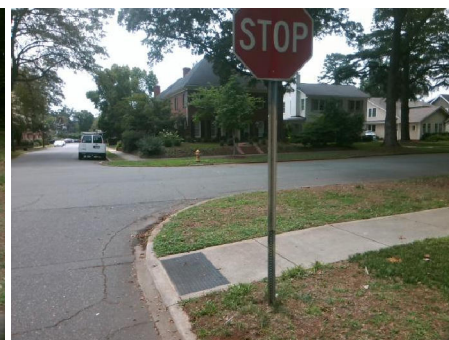
Compliance	Description	Data	Compliance	Description	Data
N/A	Ramp Length (in)	120.0	No	Ramp Slope (%)	8.6
Yes	Ramp Width (in)	60.0	Yes	Ramp XSlope (%)	1.5
N/A	Flare Type LT	N/A	N/A	Flare Type RT	N/A
N/A	Flare Slope LT (%)	N/A	N/A	Flare Slope RT (%)	N/A
N/A	Flare Traversable LT?	N/A	N/A	Flare Traversable RT?	N/A
N/A	Landing Length (in)	N/A	N/A	DWS Provided?	N/A
N/A	Landing Width (in)	N/A	N/A	DWS Contrast?	N/A
N/A	Landing Slope (%)	N/A	N/A	DWS Length (in)	N/A
N/A	Landing X Slope (%)	N/A	N/A	DWS Full Width?	N/A
N/A	Landing Curb? (Y/N)	N/A	N/A	DWS Offset (in)	N/A
N/A	Shared Landing?	N/A			
N/A	Gutter Ponding?	N/A	N/A	Gutter Slope (%)	N/A
N/A	Gutter Lip Ht (in)	N/A	N/A	Gutter X Slope (%)	N/A
N/A	Painted X Walk1?	No	N/A	Painted X Walk2?	N/A
	X Walk 1 Direction	To NE		X Walk 2 Direction	N/A
N/A	X Walk 1 Width (in)	N/A	N/A	X Walk 2 Width (in)	N/A
	X Walk 1 Slope (%)	3.7		X Walk 2 Slope (%)	N/A
	X Walk 1 X Slope (%)	0.9		X Walk 2 X Slope (%)	N/A

N/A	Ramp inside XWalk1?	N/A	N/A	Ramp inside XWalk2?	N/A
	Road Slope (%)	N/A	N/A	Clear Space?	N/A
	Road X Slope (%)	N/A	N/A	Clear Space to XWalk (in)	N/A
N/A	Any Obstructions?	N/A	N/A	Storm Grate/Utility Hazard?	N/A
	Obstruction Type			Storm Grate/Utility Type	
		N/A			N/A
		Yes		Surface Condition? (G/P)	Good

**Remove & Replace Entire Ramp.**

**R304.2.2**

**\$ 1850.00**
