# Access Compliance Report

## Public Rights-of-Way

### (Curb Ramps)

| Intersection ID: 3502 | Main Street: KIMMEL_LN | Cross Street: MENTMORE_CT | Location: SW |

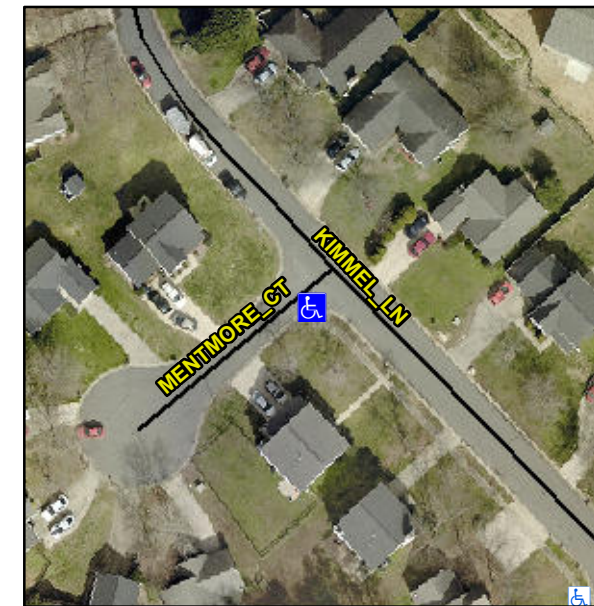
**Not Found, R304.2.2, R304.5.3**

| Compliance | Description | Data | Compliance | Description | Data |
|---|---|---|---|---|---|
| N/A | Ramp Length (in) | 52.0 | No | Ramp Slope (%) | 8.4 |
| Yes | Ramp Width (in) | 48.0 | No | Ramp XSlope (%) | 3.3 |

**Remove & Replace Entire Ramp.**
