Access Compliance Report

Public Rights-of-Way

(Curb Ramps)

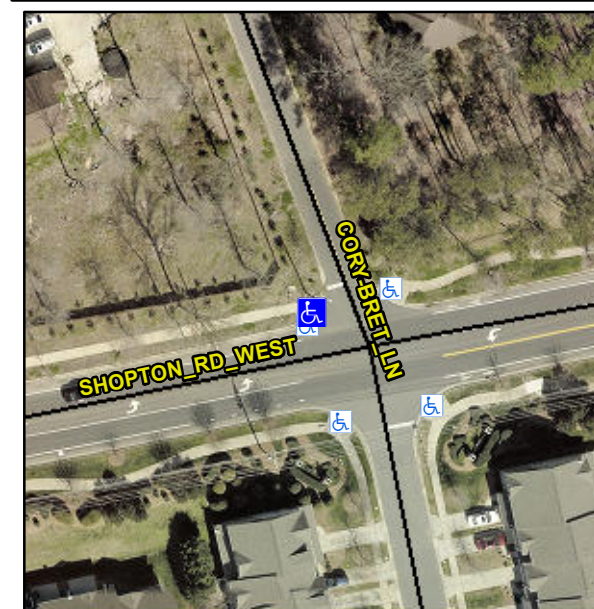
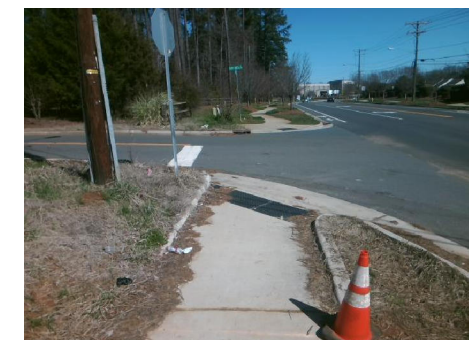
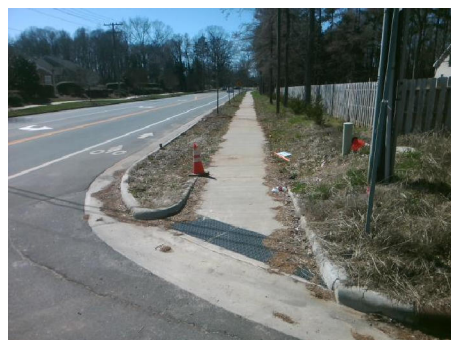
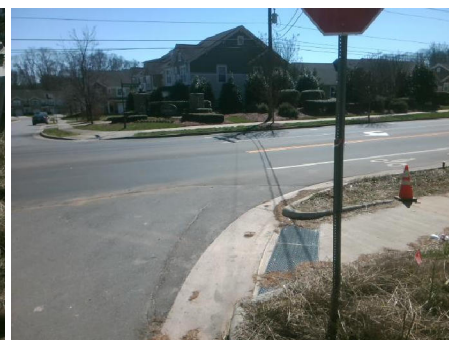
Intersection ID: 19048	Main Street: CORY-BRET_LN	Cross Street: SHOPTON_RD_WEST	Location: NW
ADA ID: 9BCC88CE3F77	Ramp Type: Directional1	Initial Pass/Fail: Fail	Overall Compliance: No
		Severity Score: 12.5	
Codes/Mitigation Info/Possible Solution		Field Measurements/Component Compliance

PROW/ADA:

R304.5.3

Compliance	Description	Data	Compliance	Description	Data
N/A	Ramp Length (in)	103.0	N/A	Grade Break?	N/A
Yes	Ramp Width (in)	70.0	N/A	Grade Break Slope (%)	0.0
Yes	Ramp Slope (%)	2.2	N/A	Grade Break XSlope (%)	0.0
No	Ramp XSlope (%)	6.1			
N/A	Flare Type LT	N/A	N/A	Flare Type RT	N/A
N/A	Flare Slope LT (%)	N/A	N/A	Flare Slope RT (%)	0.0
N/A	Flare Traversable LT?	N/A	N/A	Flare Traversable RT?	N/A
N/A	Landing Length (in)	0.0	N/A	DWS Provided?	N/A
N/A	Landing Width (in)	0.0	N/A	DWS Contrast?	N/A
N/A	Landing Slope (%)	0.0	N/A	DWS Length (in)	N/A
N/A	Landing X Slope (%)	0.0	N/A	DWS Full Width?	N/A
N/A	Landing Curb? (Y/N)	N/A	N/A	DWS Offset LT (in)	N/A
N/A	Shared Landing?	N/A	N/A	DWS Offset RT (in)	N/A
N/A	Gutter Ponding?	0.0	N/A	Gutter Slope (%)	N/A
N/A	Gutter Lip Ht (in)	0.0	N/A	Gutter X Slope (%)	N/A
N/A	Painted X Walk1?	No		Road Slope (%)	0.6
	X Walk 1 Direction	To NE		Road X Slope (%)	4.6
	X Walk 1 Width (in)	N/A		Clear Space?	N/A

X Walk 1 Slope (%)	0.6	N/A	Clear Space to XWalk (in)	N/A
	X Walk 1 X Slope (%)	4.6	N/A	Storm Grate/Utility Hazard?	N/A
N/A	Ramp inside XWalk1?	N/A		Storm Grate/Utility Type	
N/A	Any Obstructions?	N/A			N/A
	Obstruction Type		Yes	Surface Condition? (G/P)	Good
			N/A	Curb Slope (%)	0.7

Possible Solutions:

Remove & Replace Entire Ramp.

Total Cost: \$ 1600.00
