# Access Compliance Report

## Public Rights-of-Way

### (Curb Ramps)

| Intersection ID: 10033044 | Main Street: NOLLEY_CT | Cross Street: N/A | Location: NW |

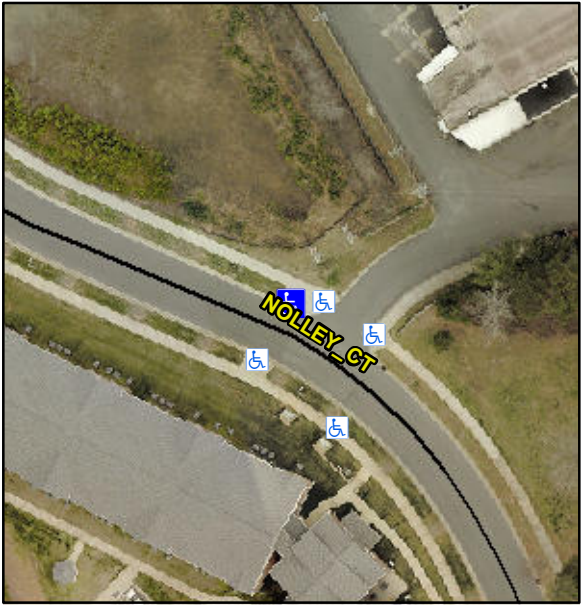
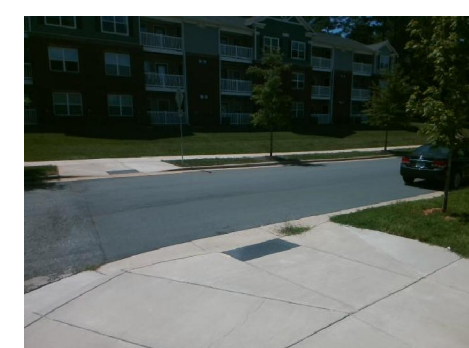
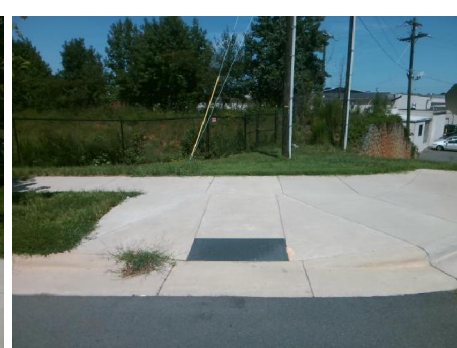
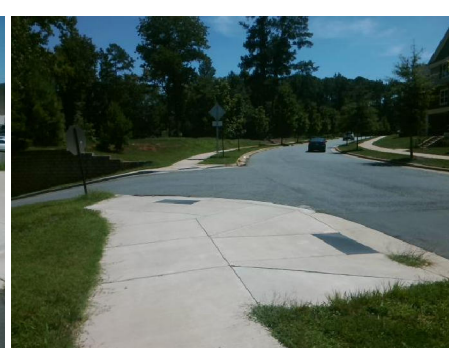
| ADA ID: 9BD753AD025D | Ramp Type: Perp | Initial Pass/Fail: Fail | Overall Compliance: No |
| | | Severity Score: 22.5 | |

| Codes/Mitigation Info/Possible Solution | | | Field Measurements/Component Compliance | | |
|---|---|--|---|---|---|
| | <b>Remove &amp; Replace Entire Ramp.</b> | | <b>No</b> | Ramp Length (in) | <b>99.0</b> |
| | | | <b>No</b> | Ramp Width (in) | <b>47.0</b> |
| <p>Surveyor Notes:</p> <p><b>N/A</b></p> <p>PROW/ADA:</p> <p><b>R304.5.1, R304.2.2, R304.5.3</b></p> | | | <b>N/A</b> | Flare Type RT | <b>N/A</b> |

| Codes/Mitigation Info/Possible Solution | | | Field Measurements/Component Compliance | | |
|---|---|--|---|---|---|
| | Possible Solutions: | | <b>Compliance</b> | <b>Description</b> | <b>Data</b> |
| Total Cost: \$ 1850.00 | | | <b>N/A</b> | Storm Grate/Utility Hazard? | <b>N/A</b> |
