# Access Compliance Report

## Public Rights-of-Way

### (Curb Ramps)

| ADA ID: 9BDBB31A55FC | Ramp Type: Perp | Initial Pass/Fail: Fail | Overall Compliance: No |

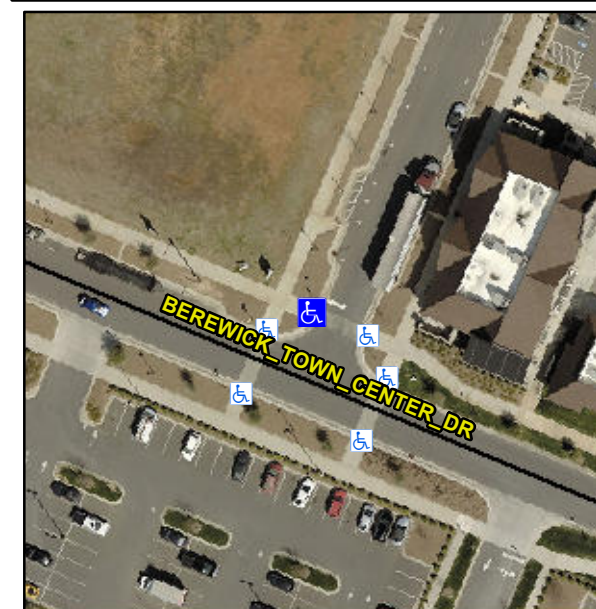
| Severity Score: 12.5 | | | |

**Not Found, R304.2.2**

| Compliance | Description | Data | Compliance | Description | Data |
|---|---|---|---|---|---|
| N/A | Ramp Length (in) | 170.0 | No | Ramp Slope (%) | 8.6 |

**Remove & Replace Entire Ramp.**

Total Cost: \$ 1850.00
