# Access Compliance Report

## Public Rights-of-Way

### (Curb Ramps)

Intersection ID: 2928	Main Street: PROSPERITY_CHURCH_RD	Cross Street: RIDGE_RD	Location: SE
ADA ID: 9BE515805C7F	Ramp Type: Perp	Initial Pass/Fail: Fail	Overall Compliance: No
Severity Score: 35			
Codes/Mitigation Info/Possible Solution		Field Measurements/Component Compliance

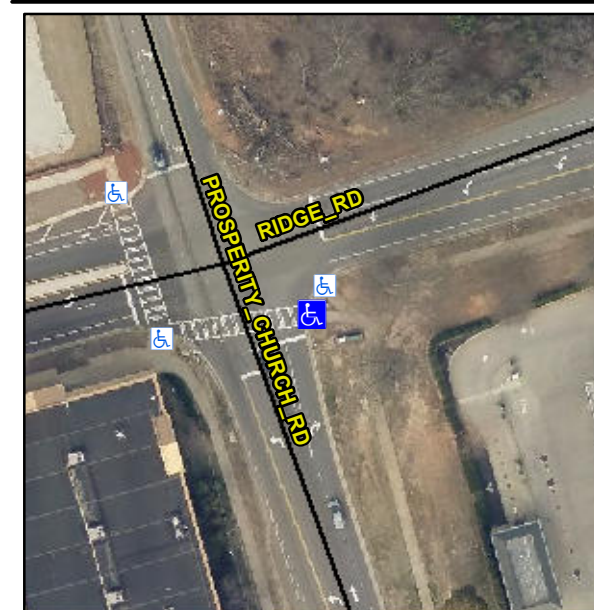
Compliance	Description	Data	Compliance	Description	Data
N/A	Ramp Length (in)	186.0	Yes	Ramp Slope (%)	15.7
No	Ramp Width (in)	47.5	No	Ramp XSlope (%)	2.4
N/A	Flare Type LT	N/A	N/A	Flare Type RT	N/A
N/A	Flare Slope LT (%)	N/A	N/A	Flare Slope RT (%)	N/A
N/A	Flare Traversable LT?	N/A	N/A	Flare Traversable RT?	N/A
N/A	Landing Length (in)	N/A	N/A	DWS Provided?	N/A
N/A	Landing Width (in)	N/A	N/A	DWS Contrast?	N/A
N/A	Landing Slope (%)	N/A	N/A	DWS Length (in)	N/A
N/A	Landing X Slope (%)	N/A	N/A	DWS Full Width?	N/A
N/A	Landing Curb? (Y/N)	N/A	N/A	DWS Offset (in)	N/A
N/A	Shared Landing?	N/A			
N/A	Gutter Ponding?	N/A	N/A	Gutter Slope (%)	N/A
N/A	Gutter Lip Ht (in)	N/A	N/A	Gutter X Slope (%)	N/A
N/A	Painted X Walk1?	Yes	N/A	Painted X Walk2?	N/A
	X Walk 1 Direction	To W		X Walk 2 Direction	N/A
N/A	X Walk 1 Width (in)	115.0	N/A	X Walk 2 Width (in)	N/A
	X Walk 1 Slope (%)	5.4		X Walk 2 Slope (%)	N/A
	X Walk 1 X Slope (%)	1.4		X Walk 2 X Slope (%)	N/A

N/A	Ramp inside XWalk1?	Yes	N/A	Ramp inside XWalk2?	N/A
	Road Slope (%)	N/A	N/A	Clear Space?	N/A
	Road X Slope (%)	N/A	N/A	Clear Space to XWalk (in)	N/A
N/A	Any Obstructions?	N/A	N/A	Storm Grate/Utility Hazard?	N/A
	Obstruction Type			Storm Grate/Utility Type	
		N/A			N/A
		Yes		Surface Condition? (G/P)	Good

**Remove & Replace Entire Ramp.**

**R304.5.1, R304.5.3**

Total Cost: \$ 1850.00
