# Access Compliance Report

## Public Rights-of-Way

### (Curb Ramps)

Intersection ID: 50762	Main Street: SCOTT_CREEK_DR	Cross Street: BACK_CREEK_CHURCH_RD	Location: NE
ADA ID: 9BFDBA660830	Ramp Type: Perp	Initial Pass/Fail: Fail	Overall Compliance: No
Severity Score: 22.5			
Codes/Mitigation Info/Possible Solution		Field Measurements/Component Compliance

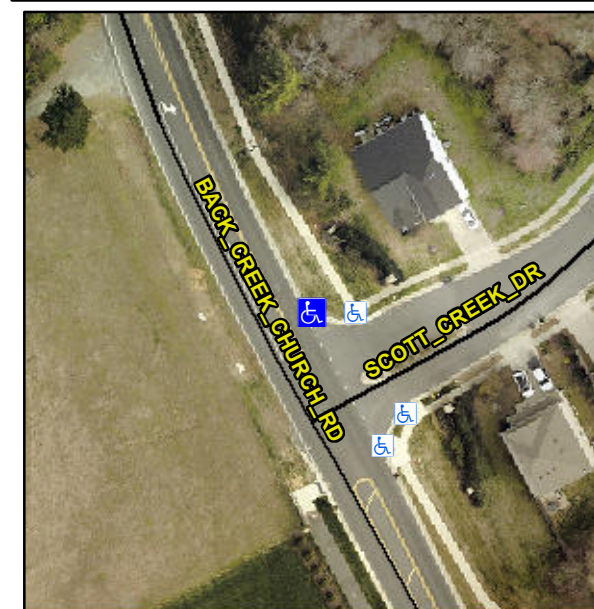
**Not Found, R304.5.1, R304.2.2, R304.5.3**

Compliance	Description	Data	Compliance	Description	Data
N/A	Ramp Length (in)	48.0	No	Ramp Slope (%)	11.1
No	Ramp Width (in)	46.5	No	Ramp XSlope (%)	2.5
N/A	Flare Type LT	N/A	N/A	Flare Type RT	N/A
N/A	Flare Slope LT (%)	N/A	N/A	Flare Slope RT (%)	N/A
N/A	Flare Traversable LT?	N/A	N/A	Flare Traversable RT?	N/A
N/A	Landing Length (in)	N/A	N/A	DWS Provided?	N/A
N/A	Landing Width (in)	N/A	N/A	DWS Contrast?	N/A
N/A	Landing Slope (%)	N/A	N/A	DWS Length (in)	N/A
N/A	Landing X Slope (%)	N/A	N/A	DWS Full Width?	N/A
N/A	Landing Curb? (Y/N)	N/A	N/A	DWS Offset (in)	N/A
N/A	Shared Landing?	N/A			
N/A	Gutter Ponding?	N/A	N/A	Gutter Slope (%)	N/A
N/A	Gutter Lip Ht (in)	N/A	N/A	Gutter X Slope (%)	N/A
N/A	Painted X Walk1?	No	N/A	Painted X Walk2?	N/A
	X Walk 1 Direction	To W		X Walk 2 Direction	N/A
N/A	X Walk 1 Width (in)	N/A	N/A	X Walk 2 Width (in)	N/A
	X Walk 1 Slope (%)	3.0		X Walk 2 Slope (%)	N/A
	X Walk 1 X Slope (%)	2.2		X Walk 2 X Slope (%)	N/A

N/A	Ramp inside XWalk1?	N/A	N/A	Ramp inside XWalk2?	N/A
	Road Slope (%)	2.2	N/A	Clear Space?	N/A
	Road X Slope (%)	3.0	N/A	Clear Space to XWalk (in)	N/A
N/A	Any Obstructions?	N/A	N/A	Storm Grate/Utility Hazard?	N/A
	Obstruction Type			Storm Grate/Utility Type	
		N/A			N/A
			Yes	Surface Condition? (G/P)	Good

**Remove & Replace Entire Ramp.**
