## **Access Compliance Report Public Rights-of-Way** (Curb Ramps)

Intersection ID: 15292 Main Street: EAST BV **Cross Street: FOUNTAIN\_VIEW** Location: NE ADA ID: 9C02752A3E7E Ramp Type: PerpDiag Initial Pass/Fail: Fail **Overall Compliance: No Severity Score:** 12.5

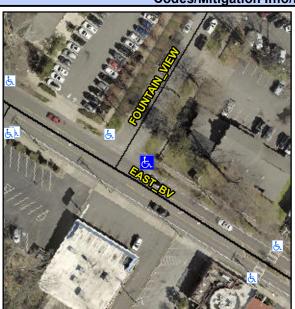
Field Measurements/Component Compilance					
Compliance Description Da		Data	Compliance Description		Data
N/A	Ramp Length (in)	65.0	Yes	Ramp Slope (%)	5.5
Yes	Ramp Width (in)	57.0	No	Ramp XSlope (%)	6.4
N/A	Flare Type LT	N/A	N/A	Flare Type RT	N/A
N/A	Flare Slope LT (%)	N/A	N/A	Flare Slope RT (%)	N/A
N/A	Flare Traversable LT?	N/A	N/A	Flare Traversable RT?	N/A
N/A	Landing Length (in)	N/A	N/A	DWS Provided?	N/A
N/A	Landing Width (in)	N/A	N/A	DWS Contrast?	N/A
N/A	Landing Slope (%)	N/A	N/A	DWS Length (in)	N/A
N/A	Landing X Slope (%)	N/A	N/A	DWS Full Width?	N/A
N/A	Landing Curb? (Y/N)	N/A	N/A	DWS Offset (in)	N/A
N/A	Shared Landing?	N/A			
N/A	Gutter Ponding?	N/A	N/A	Gutter Slope (%)	N/A
N/A	Gutter Lip Ht (in)	N/A	N/A	Gutter X Slope (%)	N/A
N/A	Painted X Walk1?	No	N/A	Painted X Walk2?	No
	X Walk 1 Direction	To NW		X Walk 2 Direction	To SW
N/A	X Walk 1 Width (in)	N/A	N/A	X Walk 2 Width (in)	N/A
	X Walk 1 Slope (%)	6.8		X Walk 2 Slope (%)	0.9

X Walk 1 X Slope (%)	0.2		X Walk 2 X Slope (%)	4.7
N/A	Ramp inside XWalk1?	N/A	N/A	Ramp inside XWalk2?	N/A
	Road Slope (%)	3.6	N/A	Clear Space?	N/A
	Road X Slope (%)	4.3	N/A	Clear Space to XWalk (in)	N/A
N/A	Any Obstructions?	N/A	N/A	Storm Grate/Utility Hazard?	N/A
	Obstruction Type			Storm Grate/Utility Type	
		N/A			N/A
			Yes	Surface Condition? (G/P)	Good

Remove & Replace Curb Ramp With Two New Directional Ramps or Equivalent.
