Access Compliance Report

Public Rights-of-Way

(Curb Ramps)

Intersection ID: 48740	Main Street: HEDGEWYCK_PL	Cross Street: SHARON_RD	Location: NE
ADA ID: 9C03FFAE0B7	Ramp Type: PerpDiag	Initial Pass/Fail: Fail	Overall Compliance: No
Severity Score: 37.5			
Codes/Mitigation Info/Possible Solution		Field Measurements/Component Compliance

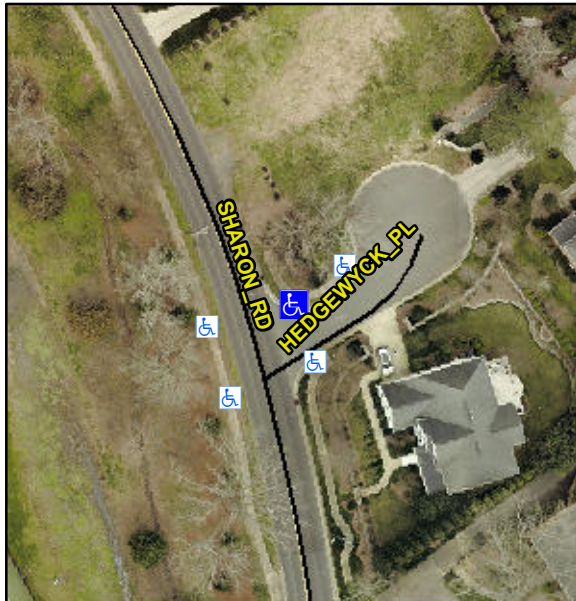
Not Found, R304.2.2, R304.5.3

Compliance	Description	Data	Compliance	Description	Data
N/A	Ramp Length (in)	48.0	No	Ramp Slope (%)	9.1
Yes	Ramp Width (in)	48.0	No	Ramp XSlope (%)	12.3
N/A	Flare Type LT	N/A	N/A	Flare Type RT	N/A
N/A	Flare Slope LT (%)	N/A	N/A	Flare Slope RT (%)	N/A
N/A	Flare Traversable LT?	N/A	N/A	Flare Traversable RT?	N/A
N/A	Landing Length (in)	N/A	N/A	DWS Provided?	N/A
N/A	Landing Width (in)	N/A	N/A	DWS Contrast?	N/A
N/A	Landing Slope (%)	N/A	N/A	DWS Length (in)	N/A
N/A	Landing X Slope (%)	N/A	N/A	DWS Full Width?	N/A
N/A	Landing Curb? (Y/N)	N/A	N/A	DWS Offset (in)	N/A
N/A	Shared Landing?	N/A			
N/A	Gutter Ponding?	N/A	N/A	Gutter Slope (%)	N/A
N/A	Gutter Lip Ht (in)	N/A	N/A	Gutter X Slope (%)	N/A
N/A	Painted X Walk1?	No	N/A	Painted X Walk2?	No
	X Walk 1 Direction	To W		X Walk 2 Direction	To S
N/A	X Walk 1 Width (in)	N/A	N/A	X Walk 2 Width (in)	N/A
	X Walk 1 Slope (%)	9.5		X Walk 2 Slope (%)	3.2
	X Walk 1 X Slope (%)	2.0		X Walk 2 X Slope (%)	12.5

N/A	Ramp inside XWalk1?	N/A	N/A	Ramp inside XWalk2?	N/A
	Road Slope (%)	11.4	N/A	Clear Space?	N/A
	Road X Slope (%)	3.8	N/A	Clear Space to XWalk (in)	N/A
N/A	Any Obstructions?	N/A	N/A	Storm Grate/Utility Hazard?	N/A
	Obstruction Type			Storm Grate/Utility Type	
		N/A			N/A
		Yes		Surface Condition? (G/P)	Good

Remove & Replace Curb Ramp With Two New Directional Ramps or Equivalent.
