# Access Compliance Report

## Public Rights-of-Way

| Intersection ID: 14253 | Main Street: LUTHER_ST | Cross Street: S_TORRENCE_ST | Location: | N |
| ADA ID: 9C0A59E0988A | Ramp Type: PerpDiag | Initial Pass/Fail: Fail | Overall Compliance: No | Severity Score: 25 |

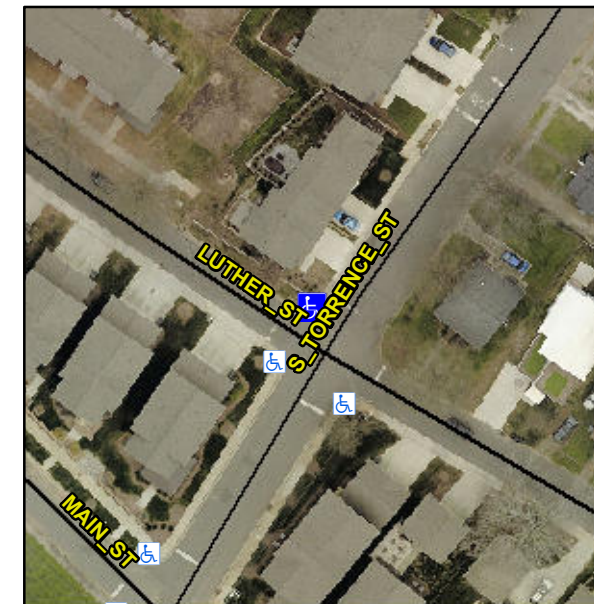
**R304.5.3**

| Compliance | Description | Data | Compliance | Description | Data |
|---|---|---|---|---|---|
| Yes | Ramp Width (in) | 49.0 | No | Ramp XSlope (%) | 14.6 |

**Remove & Replace Curb Ramp With Two New Directional Ramps or Equivalent.**

**\$ 3200.00**
