# Access Compliance Report

## Public Rights-of-Way

### (Curb Ramps)

Intersection ID: 23489	Main Street: LENHART_DR	Cross Street: SUMMERLIN_PL	Location:	N
ADA ID: 9C113C089B60	Ramp Type: PerpDiag	Initial Pass/Fail: Fail	Overall Compliance: No	Severity Score: 13.75
Codes/Mitigation Info/Possible Solution		Field Measurements/Component Compliance

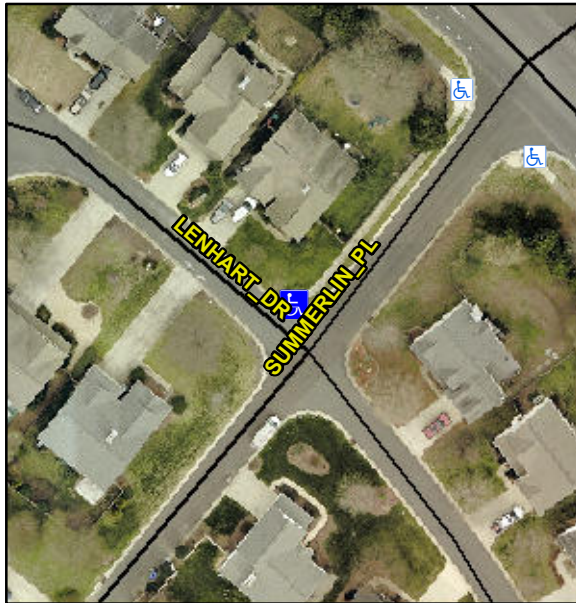
**Not Found, R304.2.2, R304.5.3**

Compliance	Description	Data	Compliance	Description	Data
N/A	Ramp Length (in)	96.0	No	Ramp Slope (%)	10.4
Yes	Ramp Width (in)	48.0	No	Ramp XSlope (%)	2.5
N/A	Flare Type LT	N/A	N/A	Flare Type RT	N/A
N/A	Flare Slope LT (%)	N/A	N/A	Flare Slope RT (%)	N/A
N/A	Flare Traversable LT?	N/A	N/A	Flare Traversable RT?	N/A
N/A	Landing Length (in)	N/A	N/A	DWS Provided?	N/A
N/A	Landing Width (in)	N/A	N/A	DWS Contrast?	N/A
N/A	Landing Slope (%)	N/A	N/A	DWS Length (in)	N/A
N/A	Landing X Slope (%)	N/A	N/A	DWS Full Width?	N/A
N/A	Landing Curb? (Y/N)	N/A	N/A	DWS Offset (in)	N/A
N/A	Shared Landing?	N/A			
N/A	Gutter Ponding?	N/A	N/A	Gutter Slope (%)	N/A
N/A	Gutter Lip Ht (in)	N/A	N/A	Gutter X Slope (%)	N/A
N/A	Painted X Walk1?	No	N/A	Painted X Walk2?	No
	X Walk 1 Direction	To SW		X Walk 2 Direction	To SE
N/A	X Walk 1 Width (in)	N/A	N/A	X Walk 2 Width (in)	N/A
	X Walk 1 Slope (%)	0.8		X Walk 2 Slope (%)	3.2
	X Walk 1 X Slope (%)	2.7		X Walk 2 X Slope (%)	1.7

N/A	Ramp inside XWalk1?	N/A	N/A	Ramp inside XWalk2?	N/A
	Road Slope (%)	2.8	N/A	Clear Space?	N/A
	Road X Slope (%)	1.7	N/A	Clear Space to XWalk (in)	N/A
N/A	Any Obstructions?	N/A	N/A	Storm Grate/Utility Hazard?	N/A
	Obstruction Type			Storm Grate/Utility Type	
		N/A			N/A
			Yes	Surface Condition? (G/P)	Good

**Remove & Replace Curb Ramp With Two New Directional Ramps or Equivalent.**
