# Access Compliance Report

## Public Rights-of-Way

### (Curb Ramps)

| Intersection ID: 18798 | Main Street: PRENTICE_PL | Cross Street: SENECA_PL | Location: SE |

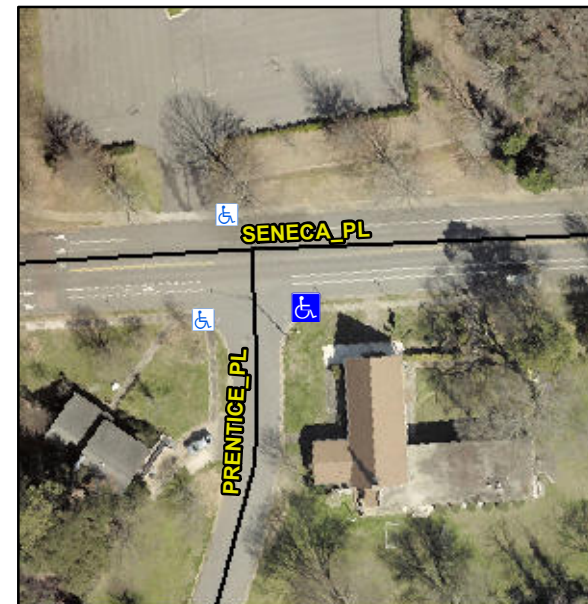
| Severity Score: 25.25 | | | |

**R304.5.3, R304.2.1, R304.2.2-Perp, R304.3.2-Para, R302.7.2**

| Compliance | Description | Data | Compliance | Description | Data |
|---|---|---|---|---|---|
| Yes | Ramp Width (in) | 48.0 | No | Ramp XSlope (%) | 3.9 |
| No | Landing Length (in) | N/A | Yes | DWS Provided? | Yes |
| No | Gutter Lip Ht (in) | 1.0 | No | Gutter X Slope (%) | 4.5 |

**Remove & Replace Curb Ramp With Two New Directional Ramps or Equivalent. Remove & Replace Gutter.**

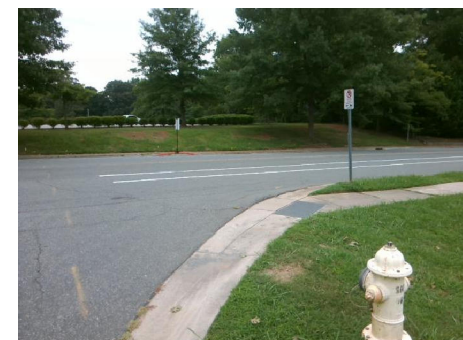
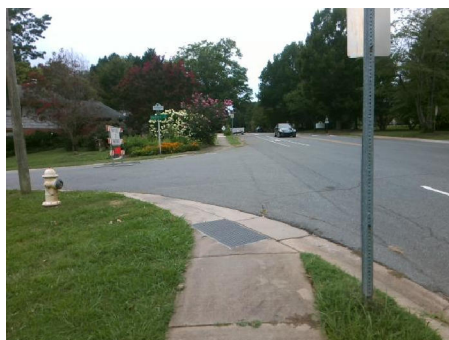
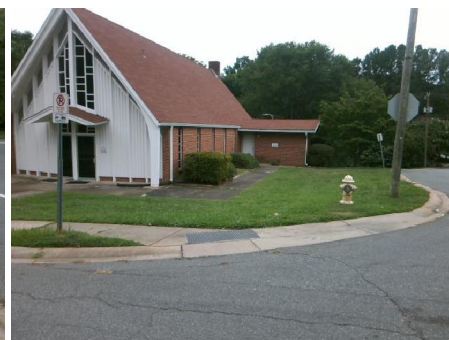
| Compliance | Description | Data | Compliance | Description | Data |
|---|---|---|---|---|---|
| N/A | Ramp Length (in) | 28.0 | Yes | Ramp Slope (%) | 6.2 |
| Yes | Gutter Ponding? | No | Yes | Gutter Slope (%) | 0.3 |
| | | | Yes | Surface Condition? (G/P) | Good |
