Access Compliance Report

Public Rights-of-Way

(Curb Ramps)

Intersection ID: 47670	Main Street: COLLINGHAM_DR	Cross Street: FENWAY_DR	Location: NW
ADA ID: 9C2405FB8A8A	Ramp Type: Perp	Initial Pass/Fail: Fail	Overall Compliance: No
Severity Score: 21.25			
Codes/Mitigation Info/Possible Solution		Field Measurements/Component Compliance

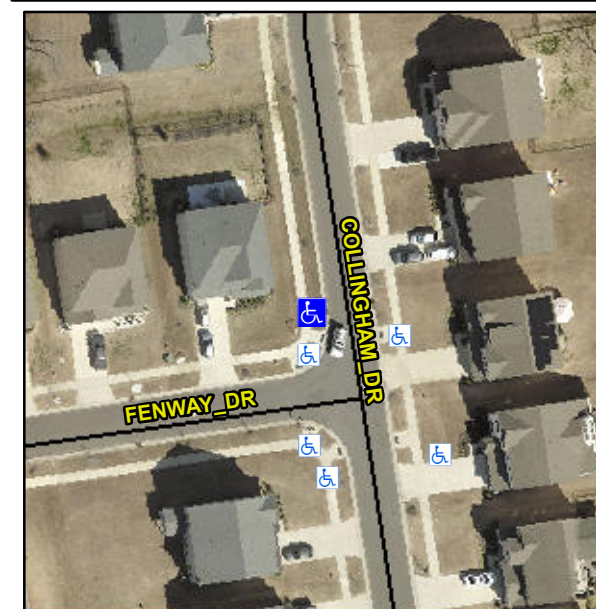
Not Found, R304.5.1, R304.2.2

Compliance	Description	Data	Compliance	Description	Data
N/A	Ramp Length (in)	96.0	No	Ramp Slope (%)	8.4
No	Ramp Width (in)	46.5	Yes	Ramp XSlope (%)	0.4
N/A	Flare Type LT	N/A	N/A	Flare Type RT	N/A
N/A	Flare Slope LT (%)	N/A	N/A	Flare Slope RT (%)	N/A
N/A	Flare Traversable LT?	N/A	N/A	Flare Traversable RT?	N/A
N/A	Landing Length (in)	N/A	N/A	DWS Provided?	N/A
N/A	Landing Width (in)	N/A	N/A	DWS Contrast?	N/A
N/A	Landing Slope (%)	N/A	N/A	DWS Length (in)	N/A
N/A	Landing X Slope (%)	N/A	N/A	DWS Full Width?	N/A
N/A	Landing Curb? (Y/N)	N/A	N/A	DWS Offset (in)	N/A
N/A	Shared Landing?	N/A			
N/A	Gutter Ponding?	N/A	N/A	Gutter Slope (%)	N/A
N/A	Gutter Lip Ht (in)	N/A	N/A	Gutter X Slope (%)	N/A
N/A	Painted X Walk1?	No	N/A	Painted X Walk2?	N/A
	X Walk 1 Direction	To E		X Walk 2 Direction	N/A
N/A	X Walk 1 Width (in)	N/A	N/A	X Walk 2 Width (in)	N/A
	X Walk 1 Slope (%)	2.7		X Walk 2 Slope (%)	N/A
	X Walk 1 X Slope (%)	1.5		X Walk 2 X Slope (%)	N/A

Remove & Replace Entire Ramp.

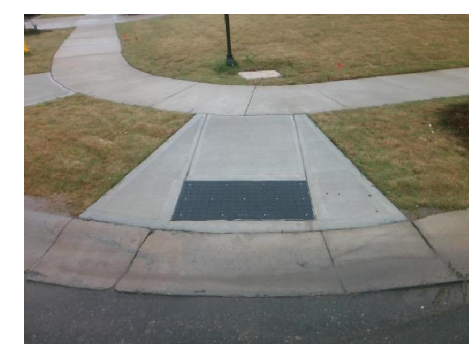
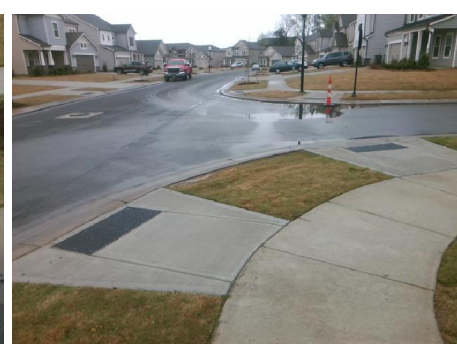
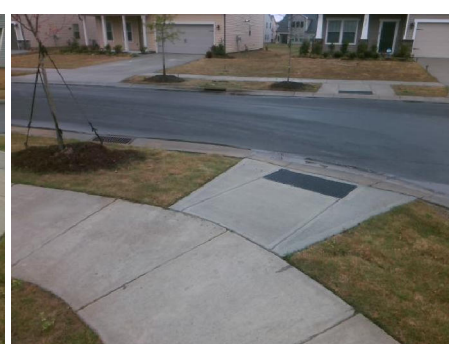
N/A	Ramp inside XWalk1?	N/A	N/A	Ramp inside XWalk2?	N/A
	Road Slope (%)	N/A	N/A	Clear Space?	N/A
	Road X Slope (%)	N/A	N/A	Clear Space to XWalk (in)	N/A
N/A	Any Obstructions?	N/A	N/A	Storm Grate/Utility Hazard?	N/A
	Obstruction Type			Storm Grate/Utility Type	
		N/A			N/A
			Yes	Surface Condition? (G/P)	Good
