# Access Compliance Report

## Public Rights-of-Way

### (Curb Ramps)

Intersection ID: 5946	Main Street: CONIFER_CR	Cross Street: FAIRES_FARM_RD	Location: W
ADA ID: 9C24FF368293	Ramp Type: PerpDiag	Initial Pass/Fail: Fail	Overall Compliance: No
Codes/Mitigation Info/Possible Solution			Severity Score: 25
			Field Measurements/Component Compliance

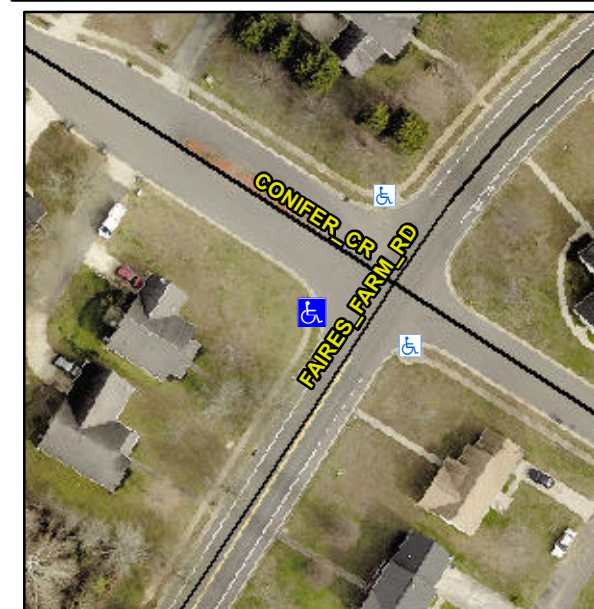
**R304.2.2, R304.5.3**

Compliance	Description	Data	Compliance	Description	Data
N/A	Ramp Length (in)	51.0	No	Ramp Slope (%)	9.4
Yes	Ramp Width (in)	48.0	No	Ramp XSlope (%)	5.4
N/A	Flare Type LT	N/A	N/A	Flare Type RT	N/A
N/A	Flare Slope LT (%)	N/A	N/A	Flare Slope RT (%)	N/A
N/A	Flare Traversable LT?	N/A	N/A	Flare Traversable RT?	N/A
N/A	Landing Length (in)	N/A	N/A	DWS Provided?	N/A
N/A	Landing Width (in)	N/A	N/A	DWS Contrast?	N/A
N/A	Landing Slope (%)	N/A	N/A	DWS Length (in)	N/A
N/A	Landing X Slope (%)	N/A	N/A	DWS Full Width?	N/A
N/A	Landing Curb? (Y/N)	N/A	N/A	DWS Offset (in)	N/A
N/A	Shared Landing?	N/A			
N/A	Gutter Ponding?	N/A	N/A	Gutter Slope (%)	N/A
N/A	Gutter Lip Ht (in)	N/A	N/A	Gutter X Slope (%)	N/A
N/A	Painted X Walk1?	No	N/A	Painted X Walk2?	No
	X Walk 1 Direction	To S		X Walk 2 Direction	To N
N/A	X Walk 1 Width (in)	N/A	N/A	X Walk 2 Width (in)	N/A
	X Walk 1 Slope (%)	1.1		X Walk 2 Slope (%)	5.9
	X Walk 1 X Slope (%)	5.3		X Walk 2 X Slope (%)	4.6

N/A	Ramp inside XWalk1?	N/A	N/A	Ramp inside XWalk2?	N/A
	Road Slope (%)	6.7	N/A	Clear Space?	N/A
	Road X Slope (%)	2.4	N/A	Clear Space to XWalk (in)	N/A
N/A	Any Obstructions?	N/A	N/A	Storm Grate/Utility Hazard?	N/A
	Obstruction Type			Storm Grate/Utility Type	
		N/A			N/A
		Yes		Surface Condition? (G/P)	Good

**Remove & Replace Curb Ramp With Two New Directional Ramps or Equivalent.**

Total Cost: \$ 3200.00
