# Access Compliance Report

## Public Rights-of-Way

### (Curb Ramps)

Intersection ID: 11693	Main Street: E_12TH_ST	Cross Street: N_COLLEGE_ST	Location: S
ADA ID: 9C2769C50B24	Ramp Type: Directional1	Initial Pass/Fail: Fail	Overall Compliance: No
Severity Score: 58.75			
Codes/Mitigation Info/Possible Solution		Field Measurements/Component Compliance

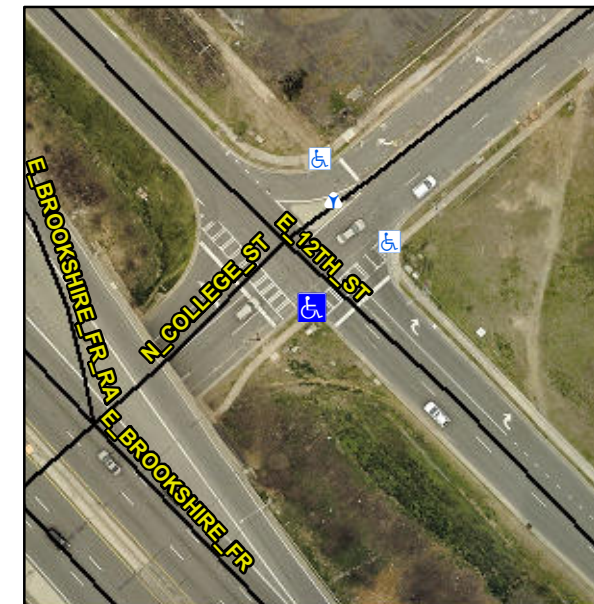
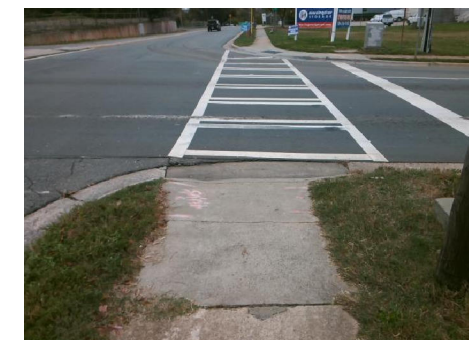
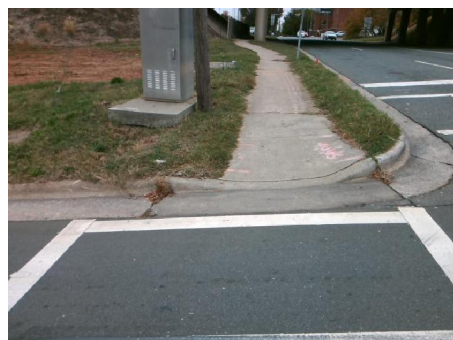
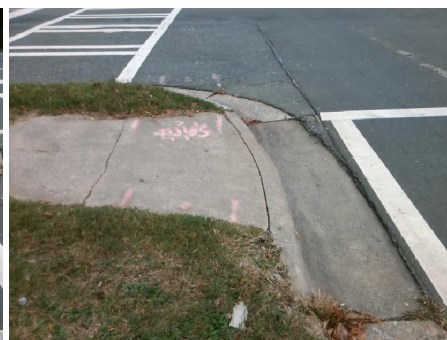
Compliance	Description	Data	Compliance	Description	Data
N/A	Ramp Length (in)	47.0	N/A	Grade Break?	N/A
No	Ramp Width (in)	45.0	N/A	Grade Break Slope (%)	0.0
No	Ramp Slope (%)	15.1	N/A	Grade Break XSlope (%)	0.0
No	Ramp XSlope (%)	8.0			
N/A	Flare Type LT	N/A	N/A	Flare Type RT	N/A
N/A	Flare Slope LT (%)	N/A	N/A	Flare Slope RT (%)	0.0
N/A	Flare Traversable LT?	N/A	N/A	Flare Traversable RT?	N/A
N/A	Landing Length (in)	0.0	N/A	DWS Provided?	N/A
N/A	Landing Width (in)	0.0	N/A	DWS Contrast?	N/A
N/A	Landing Slope (%)	0.0	N/A	DWS Length (in)	N/A
N/A	Landing X Slope (%)	0.0	N/A	DWS Full Width?	N/A
N/A	Landing Curb? (Y/N)	N/A	N/A	DWS Offset LT (in)	N/A
N/A	Shared Landing?	N/A	N/A	DWS Offset RT (in)	N/A
N/A	Gutter Ponding?	0.0	N/A	Gutter Slope (%)	N/A
N/A	Gutter Lip Ht (in)	2.0	N/A	Gutter X Slope (%)	N/A
N/A	Painted X Walk1?	Yes		Road Slope (%)	0.5
	X Walk 1 Direction	To NE		Road X Slope (%)	10.4
	X Walk 1 Width (in)	105.0		Clear Space?	N/A

X Walk 1 Slope (%)	0.5	N/A	Clear Space to XWalk (in)	N/A
	X Walk 1 X Slope (%)	10.4	N/A	Storm Grate/Utility Hazard?	N/A
N/A	Ramp inside XWalk1?	Yes		Storm Grate/Utility Type	
N/A	Any Obstructions?	N/A			N/A
	Obstruction Type		Yes	Surface Condition? (G/P)	Good
			N/A	Curb Slope (%)	15.4

**Remove & Replace Entire Ramp.**

**R304.5.1, R304.2.2, R304.5.3**
