Access Compliance Report

Public Rights-of-Way

(Curb Ramps)

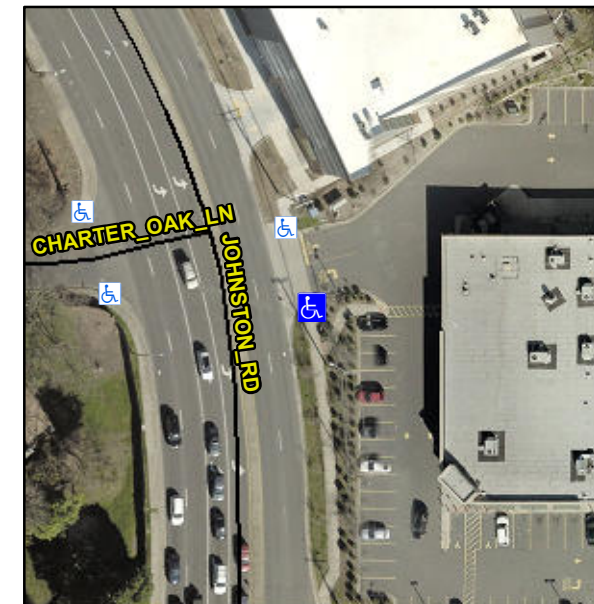
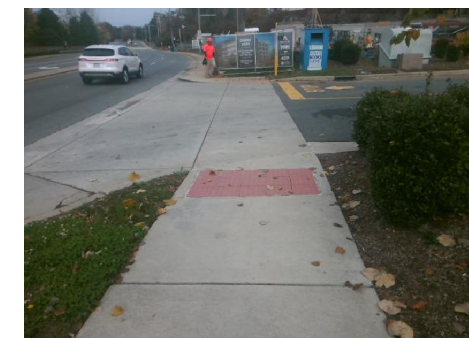
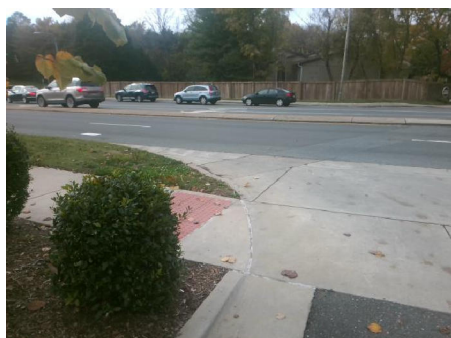
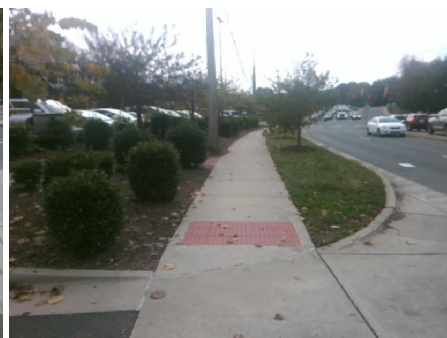
Intersection ID: N/A	Main Street: JOHNSTON_RD	Cross Street: N/A	Location: SE
ADA ID: 9C2B50CA3828	Ramp Type: Directional1	Initial Pass/Fail: Fail	Overall Compliance: No
Codes/Mitigation Info/Possible Solution		Field Measurements/Component Compliance	
Severity Score: 1.25

Compliance	Description	Data	Compliance	Description	Data
N/A	Ramp Length (in)	36.0	N/A	Grade Break?	N/A
Yes	Ramp Width (in)	60.0	N/A	Grade Break Slope (%)	0.0
Yes	Ramp Slope (%)	2.5	N/A	Grade Break XSlope (%)	0.0
No	Ramp XSlope (%)	2.7			
N/A	Flare Type LT	N/A	N/A	Flare Type RT	N/A
N/A	Flare Slope LT (%)	N/A	N/A	Flare Slope RT (%)	0.0
N/A	Flare Traversable LT?	N/A	N/A	Flare Traversable RT?	N/A
N/A	Landing Length (in)	0.0	N/A	DWS Provided?	N/A
N/A	Landing Width (in)	0.0	N/A	DWS Contrast?	N/A
N/A	Landing Slope (%)	0.0	N/A	DWS Length (in)	N/A
N/A	Landing X Slope (%)	0.0	N/A	DWS Full Width?	N/A
N/A	Landing Curb? (Y/N)	N/A	N/A	DWS Offset LT (in)	N/A
N/A	Shared Landing?	N/A	N/A	DWS Offset RT (in)	N/A
N/A	Gutter Ponding?	0.0	N/A	Gutter Slope (%)	N/A
N/A	Gutter Lip Ht (in)	0.0	N/A	Gutter X Slope (%)	N/A
N/A	Painted X Walk1?	No		Road Slope (%)	0.7
	X Walk 1 Direction	To N		Road X Slope (%)	1.1
	X Walk 1 Width (in)	N/A		Clear Space?	N/A

X Walk 1 Slope (%)	0.7	N/A	Clear Space to XWalk (in)	N/A
	X Walk 1 X Slope (%)	1.1	N/A	Storm Grate/Utility Hazard?	N/A
N/A	Ramp inside XWalk1?	N/A		Storm Grate/Utility Type	
N/A	Any Obstructions?	N/A			N/A
	Obstruction Type		Yes	Surface Condition? (G/P)	Good
			N/A	Curb Slope (%)	1.9

Possible Solutions:

Remove & Replace Entire Ramp.

R304.5.3
