Access Compliance Report

Public Rights-of-Way

(Curb Ramps)

Intersection ID: 20185	Main Street: FAIRVIEW_RD	Cross Street: PIEDMONT_ROW_DR	Location: SW
ADA ID: 9C3C048D20BA	Ramp Type: Perp	Initial Pass/Fail: Fail	Overall Compliance: No
		Severity Score: 12.5

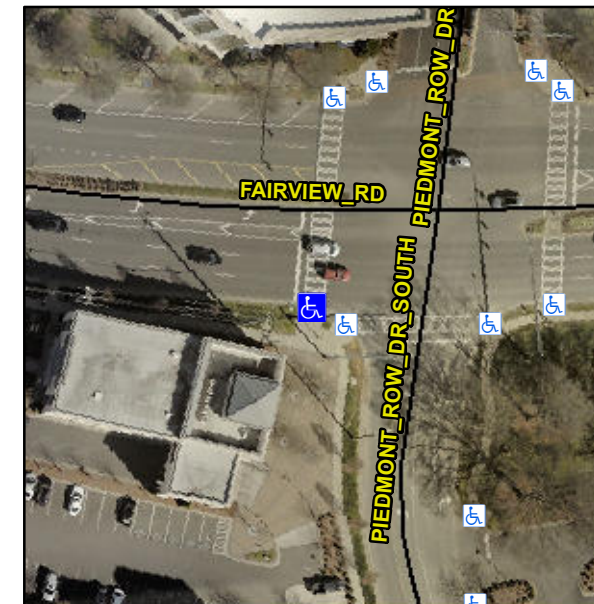
Compliance	Description	Data	Compliance	Description	Data
N/A	Ramp Length (in)	95.0	No	Ramp Slope (%)	8.8
Yes	Ramp Width (in)	48.0	Yes	Ramp XSlope (%)	1.2
N/A	Flare Type LT	N/A	N/A	Flare Type RT	N/A
N/A	Flare Slope LT (%)	N/A	N/A	Flare Slope RT (%)	N/A
N/A	Flare Traversable LT?	N/A	N/A	Flare Traversable RT?	N/A
N/A	Landing Length (in)	N/A	N/A	DWS Provided?	N/A
N/A	Landing Width (in)	N/A	N/A	DWS Contrast?	N/A
N/A	Landing Slope (%)	N/A	N/A	DWS Length (in)	N/A
N/A	Landing X Slope (%)	N/A	N/A	DWS Full Width?	N/A
N/A	Landing Curb? (Y/N)	N/A	N/A	DWS Offset (in)	N/A
N/A	Shared Landing?	N/A			
N/A	Gutter Ponding?	N/A	N/A	Gutter Slope (%)	N/A
N/A	Gutter Lip Ht (in)	N/A	N/A	Gutter X Slope (%)	N/A
N/A	Painted X Walk1?	Yes	N/A	Painted X Walk2?	N/A
	X Walk 1 Direction	To NE		X Walk 2 Direction	N/A
N/A	X Walk 1 Width (in)	109.0	N/A	X Walk 2 Width (in)	N/A
	X Walk 1 Slope (%)	0.1		X Walk 2 Slope (%)	N/A
	X Walk 1 X Slope (%)	1.6		X Walk 2 X Slope (%)	N/A

N/A	Ramp inside XWalk1?	Yes	N/A	Ramp inside XWalk2?	N/A
	Road Slope (%)	N/A	N/A	Clear Space?	N/A
	Road X Slope (%)	N/A	N/A	Clear Space to XWalk (in)	N/A
N/A	Any Obstructions?	N/A	N/A	Storm Grate/Utility Hazard?	N/A
	Obstruction Type			Storm Grate/Utility Type	
		N/A			N/A
			Yes	Surface Condition? (G/P)	Good

Remove & Replace Entire Ramp.

R304.2.2
