# Access Compliance Report

## Public Rights-of-Way

### (Curb Ramps)

| Intersection ID: 9824 | Main Street: DINGLEWOOD_AV | Cross Street: TREMBETH_DR | Location: SE |

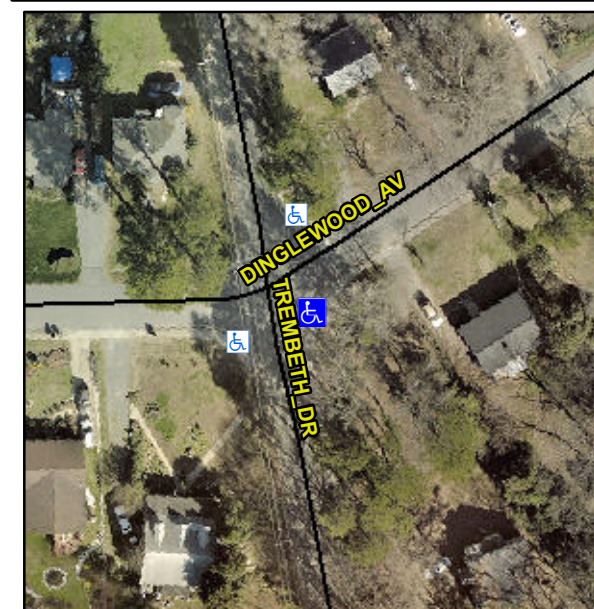
**Not Found, R304.5.1, R304.2.2, R304.5.3**

| Compliance | Description | Data | Compliance | Description | Data |
|---|---|---|---|---|---|
| N/A | Ramp Length (in) | 60.0 | No | Ramp Slope (%) | 9.3 |
| No | Ramp Width (in) | 47.0 | No | Ramp XSlope (%) | 4.5 |

**Remove & Replace Curb Ramp With Two New Directional Ramps or Equivalent.**
