Access Compliance Report Public Rights-of-Way (Curb Ramps)

Intersection ID: 13696Main Street: S_KINGS_DRCross Street: E_3RD_STLocation: WADA ID: 9C636942702BRamp Type: PerpDiagInitial Pass/Fail: FailOverall Compliance: NoSeverity Score: 10

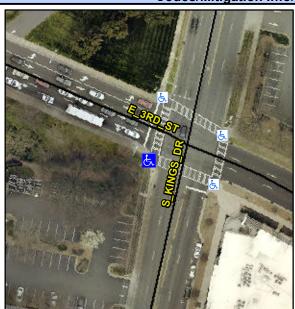
Field Measurements/Component Compliance					
Comp	liance Description	Data	Comp	liance Description	Data
N/A	Ramp Length (in)	57.0	Yes	Ramp Slope (%)	6.6
No	Ramp Width (in)	47.0	Yes	Ramp XSlope (%)	3.3
N/A	Flare Type LT	N/A	N/A	Flare Type RT	N/A
N/A	Flare Slope LT (%)	N/A	N/A	Flare Slope RT (%)	N/A
N/A	Flare Traversable LT?	N/A	N/A	Flare Traversable RT?	N/A
N/A	Landing Length (in)	N/A	N/A	DWS Provided?	N/A
N/A	Landing Width (in)	N/A	N/A	DWS Contrast?	N/A
N/A	Landing Slope (%)	N/A	N/A	DWS Length (in)	N/A
N/A	Landing X Slope (%)	N/A	N/A	DWS Full Width?	N/A
N/A	Landing Curb? (Y/N)	N/A	N/A	DWS Offset (in)	N/A
N/A	Shared Landing?	N/A			
N/A	Gutter Ponding?	N/A	N/A	Gutter Slope (%)	N/A
N/A	Gutter Lip Ht (in)	N/A	N/A	Gutter X Slope (%)	N/A
N/A	Painted X Walk1?	Yes	N/A	Painted X Walk2?	Yes
	X Walk 1 Direction	To SE		X Walk 2 Direction	To NE
N/A	X Walk 1 Width (in)	95.0	N/A	X Walk 2 Width (in)	95.0
	X Walk 1 Slope (%)	5.5		X Walk 2 Slope (%)	3.3

X Walk 1 X Slope (%)	2.3		X Walk 2 X Slope (%)	3.8
N/A	Ramp inside XWalk1?	Yes	N/A	Ramp inside XWalk2?	Yes
	Road Slope (%)	5.2	N/A	Clear Space?	N/A
	Road X Slope (%)	2.9	N/A	Clear Space to XWalk (in)	N/A
N/A	Any Obstructions?	N/A	N/A	Storm Grate/Utility Hazard?	N/A
	Obstruction Type			Storm Grate/Utility Type	
		N/A			N/A
			Yes	Surface Condition? (G/P)	Good

Remove & Replace Curb Ramp With
Two New Directional Ramps or
Equivalent.

PROW/ADA:
Not Found, R304.5.1
