## Access Compliance Report Public Rights-of-Way (Curb Ramps)

Intersection ID: 2768 Main Street: BELL'S\_MILL\_DR Cross Street: CRAIL\_CT Location: SW

ADA ID: 9C6A66C9A9D9 Ramp Type: PerpDiag Initial Pass/Fail: Pass Overall Compliance: No Severity Score: 15

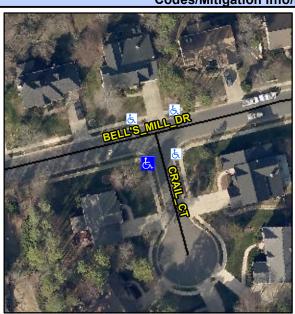
Field Measurements/Component Compliance					
Compliance Description		Data	Compliance Description		Data
N/A	Ramp Length (in)	48.0	Yes	Ramp Slope (%)	5.2
Yes	Ramp Width (in)	48.0	Yes	Ramp XSlope (%)	2.0
N/A	Flare Type LT	Sloped	N/A	Flare Type RT	N/A
N/A	Flare Slope LT (%)	3.1	Yes	Flare Slope RT (%)	0.3
N/A	Flare Traversable LT?	Yes	N/A	Flare Traversable RT?	Yes
No	Landing Length (in)	47.0	No	DWS Provided?	No
Yes	Landing Width (in)	48.0	N/A	DWS Contrast?	No
No	Landing Slope (%)	3.3	N/A	DWS Length (in)	N/A
Yes	Landing X Slope (%)	1.1	N/A	DWS Full Width?	No
N/A	Landing Curb? (Y/N)	No	N/A	DWS Offset (in)	N/A
N/A	Shared Landing?	No			
Yes	Gutter Ponding?	No	No	Gutter Slope (%)	8.8
Yes	Gutter Lip Ht (in)	0.0	Yes	Gutter X Slope (%)	1.9
N/A	Painted X Walk1?	No	N/A	Painted X Walk2?	No
	X Walk 1 Direction	To E		X Walk 2 Direction	To N
N/A	X Walk 1 Width (in)	N/A	N/A	X Walk 2 Width (in)	N/A
	X Walk 1 Slope (%)	7.4		X Walk 2 Slope (%)	2.0

X Walk 1 X Slope (%)	0.6		X Walk 2 X Slope (%)	3.5
N/A	Ramp inside XWalk1?	N/A	N/A	Ramp inside XWalk2?	N/A
	Road Slope (%)	0.9	N/A	Clear Space?	Yes
	Road X Slope (%)	7.9	N/A	Clear Space to XWalk (in)	N/A
Yes	Any Obstructions?	No	Yes	Storm Grate/Utility Hazard?	No
	Obstruction Type			Storm Grate/Utility Type	
		N/A			N/A
			Yes	Surface Condition? (G/P)	Good

Remove & Replace Curb Ramp With
Two New Directional Ramps or
Equivalent. Remove & Replace
Gutter.
