Access Compliance Report

Public Rights-of-Way

(Curb Ramps)

Intersection ID: 18627	Main Street: CEDARBARK_DR	Cross Street: CLIFTON_MEADOW_DR	Location: SW
ADA ID: 9C6DDF06D407	Ramp Type: PerpDiag	Initial Pass/Fail: Fail	Overall Compliance: No
		Severity Score: 25

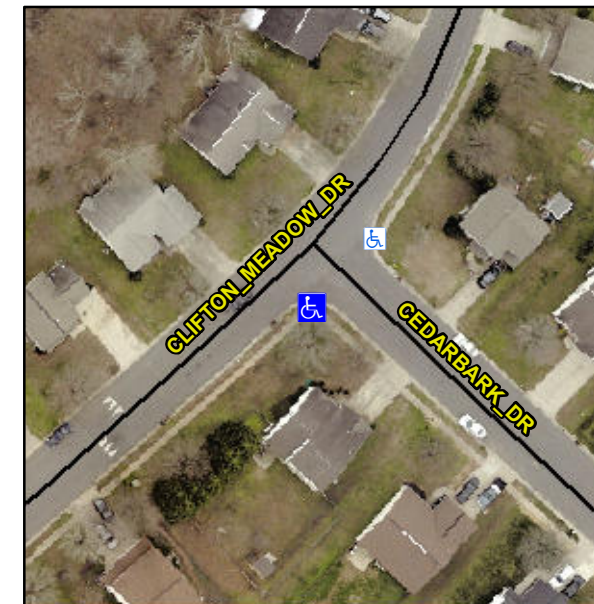
Compliance	Description	Data	Compliance	Description	Data
N/A	Ramp Length (in)	72.0	Yes	Ramp Slope (%)	7.1
Yes	Ramp Width (in)	48.0	No	Ramp XSlope (%)	8.7
N/A	Flare Type LT	N/A	N/A	Flare Type RT	N/A
N/A	Flare Slope LT (%)	N/A	N/A	Flare Slope RT (%)	N/A
N/A	Flare Traversable LT?	N/A	N/A	Flare Traversable RT?	N/A
N/A	Landing Length (in)	N/A	N/A	DWS Provided?	N/A
N/A	Landing Width (in)	N/A	N/A	DWS Contrast?	N/A
N/A	Landing Slope (%)	N/A	N/A	DWS Length (in)	N/A
N/A	Landing X Slope (%)	N/A	N/A	DWS Full Width?	N/A
N/A	Landing Curb? (Y/N)	N/A	N/A	DWS Offset (in)	N/A
N/A	Shared Landing?	N/A			
N/A	Gutter Ponding?	N/A	N/A	Gutter Slope (%)	N/A
N/A	Gutter Lip Ht (in)	N/A	N/A	Gutter X Slope (%)	N/A
N/A	Painted X Walk1?	No	N/A	Painted X Walk2?	No
	X Walk 1 Direction	To NW		X Walk 2 Direction	To NE
N/A	X Walk 1 Width (in)	N/A	N/A	X Walk 2 Width (in)	N/A
	X Walk 1 Slope (%)	2.0		X Walk 2 Slope (%)	2.3
	X Walk 1 X Slope (%)	3.1		X Walk 2 X Slope (%)	4.9

N/A	Ramp inside XWalk1?	N/A	N/A	Ramp inside XWalk2?	N/A
	Road Slope (%)	4.0	N/A	Clear Space?	N/A
	Road X Slope (%)	2.4	N/A	Clear Space to XWalk (in)	N/A
N/A	Any Obstructions?	N/A	N/A	Storm Grate/Utility Hazard?	N/A
	Obstruction Type			Storm Grate/Utility Type	
		N/A			N/A
			Yes	Surface Condition? (G/P)	Good

Remove & Replace Curb Ramp With Two New Directional Ramps or Equivalent.

R304.5.3

\$ 3200.00
