## Access Compliance Report Public Rights-of-Way (Curb Ramps)

Intersection ID: 52449 Main Street: TRANQUIL\_OAK\_PL Cross Street: PAT\_GARRETT\_ST Location: SW

ADA ID: 9C6E357A42F2 Ramp Type: Directional1 Initial Pass/Fail: Fail Overall Compliance: No Severity Score: 25

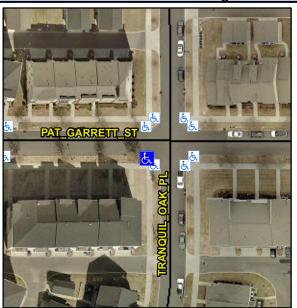
Possible Solutions:	Comp	oliance Description	Data
Remove & Replace Entire Ramp.	N/A	Ramp Length (in)	67.0
	Yes	Ramp Width (in)	66.0
	No	Ramp Slope (%)	14.2
	Yes	Ramp XSlope (%)	0.8
	N/A	Flare Type LT	N/A
	N/A	Flare Slope LT (%)	N/A
Surveyor Notes:	N/A	Flare Traversable LT?	N/A
N/A	N/A	Landing Length (in)	0.0
	N/A	Landing Width (in)	0.0
	N/A	Landing Slope (%)	0.0
	N/A	Landing X Slope (%)	0.0
PROW/ADA:	N/A	Landing Curb? (Y/N)	N/A
R304.2.2	N/A	Shared Landing?	N/A
	N/A	Gutter Ponding?	0.0
	N/A	Gutter Lip Ht (in)	2.0
	N/A	Painted X Walk1?	No
		X Walk 1 Direction	To N
		X Walk 1 Width (in)	N/A
		X Walk 1 Slope (%)	1.8
		X Walk 1 X Slope (%)	2.8
	N/A	Ramp inside XWalk1?	N/A
	N/A	Any Obstructions?	N/A
