Intersection ID: 29331	Main Street: ELIZABETH_RD	Cross Street: NEVIN_BROOK_RD	Location:	N
ADA ID: 9C72181C2186	Ramp Type: PerpDiag	Initial Pass/Fail: Fail	Overall Compliance: No	Severity Score: 21.25

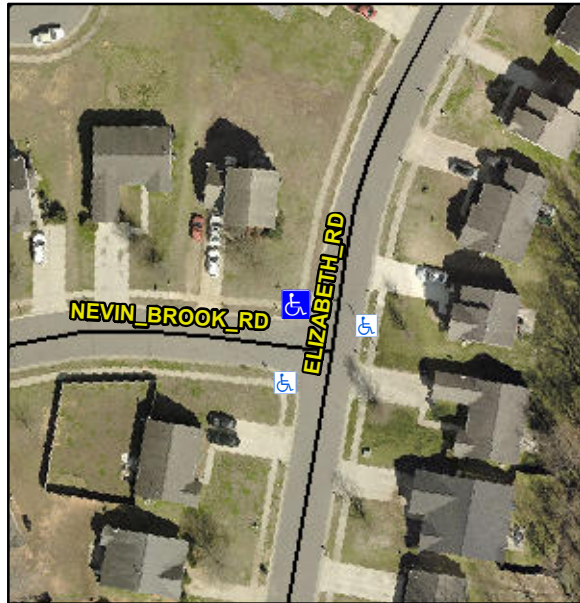
### R304.5.1, R304.2.2

Compliance	Description	Data	Compliance	Description	Data
N/A	Ramp Length (in)	53.5	No	Ramp Slope (%)	8.5
No	Ramp Width (in)	40.0	Yes	Ramp XSlope (%)	0.8
N/A	Flare Type LT	N/A	N/A	Flare Type RT	N/A
N/A	Flare Slope LT (%)	N/A	N/A	Flare Slope RT (%)	N/A
N/A	Flare Traversable LT?	N/A	N/A	Flare Traversable RT?	N/A
N/A	Landing Length (in)	N/A	N/A	DWS Provided?	N/A
N/A	Landing Width (in)	N/A	N/A	DWS Contrast?	N/A
N/A	Landing Slope (%)	N/A	N/A	DWS Length (in)	N/A
N/A	Landing X Slope (%)	N/A	N/A	DWS Full Width?	N/A
N/A	Landing Curb? (Y/N)	N/A	N/A	DWS Offset (in)	N/A
N/A	Shared Landing?	N/A			
N/A	Gutter Ponding?	Yes	N/A	Gutter Slope (%)	N/A
N/A	Gutter Lip Ht (in)	N/A	N/A	Gutter X Slope (%)	N/A
N/A	Painted X Walk1?	No	N/A	Painted X Walk2?	No
	X Walk 1 Direction	To SW		X Walk 2 Direction	To NE
N/A	X Walk 1 Width (in)	N/A	N/A	X Walk 2 Width (in)	N/A
	X Walk 1 Slope (%)	0.7		X Walk 2 Slope (%)	1.6
	X Walk 1 X Slope (%)	1.2		X Walk 2 X Slope (%)	0.2

N/A	Ramp inside XWalk1?	N/A	N/A	Ramp inside XWalk2?	N/A
	Road Slope (%)	1.2	N/A	Clear Space?	N/A
	Road X Slope (%)	1.6	N/A	Clear Space to XWalk (in)	N/A
N/A	Any Obstructions?	N/A	N/A	Storm Grate/Utility Hazard?	N/A
	Obstruction Type			Storm Grate/Utility Type	
		N/A			N/A
			Yes	Surface Condition? (G/P)	Good

**Remove & Replace Curb Ramp With Two New Directional Ramps or Equivalent.**
