Access Compliance Report

Public Rights-of-Way

(Curb Ramps)

Intersection ID: 46789	Main Street: STOWE_ACRES_DR	Cross Street: WILTON_GATE_DR	Location: SW
ADA ID: 9C747065C935	Ramp Type: Perp	Initial Pass/Fail: Fail	Overall Compliance: No
Severity Score: 12.5			
Codes/Mitigation Info/Possible Solution		Field Measurements/Component Compliance

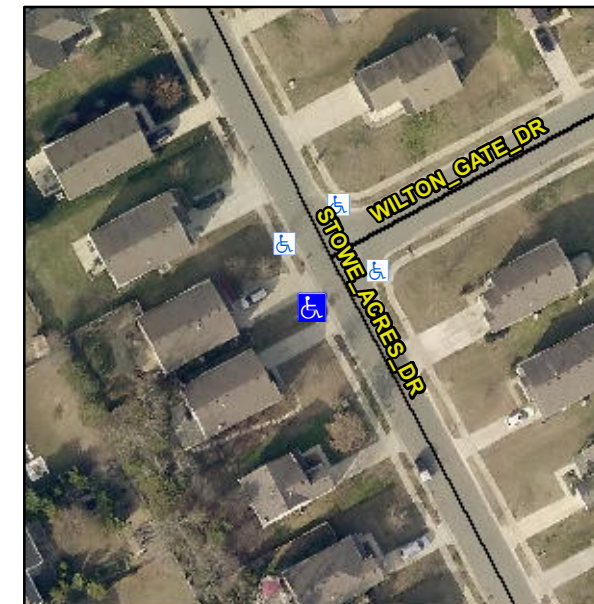
Compliance	Description	Data	Compliance	Description	Data
N/A	Ramp Length (in)	46.0	No	Ramp Slope (%)	10.5
Yes	Ramp Width (in)	48.5	Yes	Ramp XSlope (%)	0.9
N/A	Flare Type LT	N/A	N/A	Flare Type RT	N/A
N/A	Flare Slope LT (%)	N/A	N/A	Flare Slope RT (%)	N/A
N/A	Flare Traversable LT?	N/A	N/A	Flare Traversable RT?	N/A
N/A	Landing Length (in)	N/A	N/A	DWS Provided?	N/A
N/A	Landing Width (in)	N/A	N/A	DWS Contrast?	N/A
N/A	Landing Slope (%)	N/A	N/A	DWS Length (in)	N/A
N/A	Landing X Slope (%)	N/A	N/A	DWS Full Width?	N/A
N/A	Landing Curb? (Y/N)	N/A	N/A	DWS Offset (in)	N/A
N/A	Shared Landing?	N/A			
N/A	Gutter Ponding?	N/A	N/A	Gutter Slope (%)	N/A
N/A	Gutter Lip Ht (in)	N/A	N/A	Gutter X Slope (%)	N/A
N/A	Painted X Walk1?	No	N/A	Painted X Walk2?	N/A
	X Walk 1 Direction	To E		X Walk 2 Direction	N/A
N/A	X Walk 1 Width (in)	N/A	N/A	X Walk 2 Width (in)	N/A
	X Walk 1 Slope (%)	1.9		X Walk 2 Slope (%)	N/A
	X Walk 1 X Slope (%)	0.5		X Walk 2 X Slope (%)	N/A

Possible Solutions:

Remove & Replace Entire Ramp.

R304.2.2

\$ 1850.00

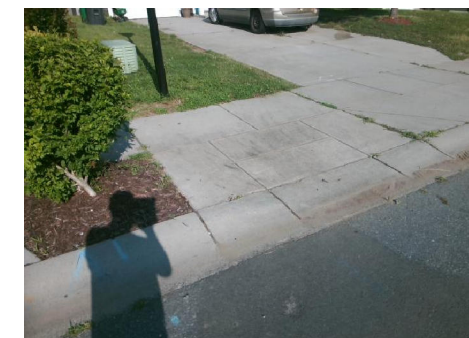
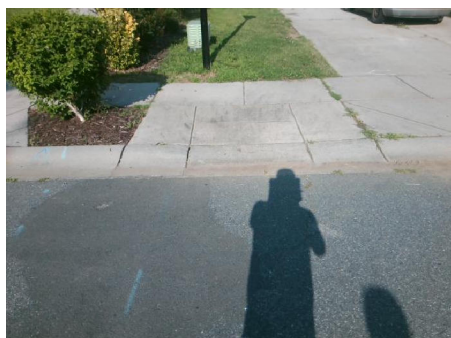
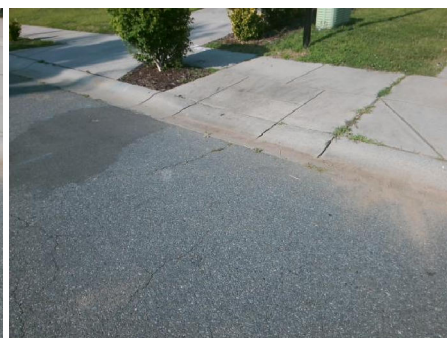
N/A	Ramp inside XWalk1?	N/A	N/A	Ramp inside XWalk2?	N/A
	Road Slope (%)	N/A	N/A	Clear Space?	N/A
	Road X Slope (%)	N/A	N/A	Clear Space to XWalk (in)	N/A
N/A	Any Obstructions?	N/A	N/A	Storm Grate/Utility Hazard?	N/A
	Obstruction Type			Storm Grate/Utility Type	
		N/A			N/A
			Yes	Surface Condition? (G/P)	Good
