Access Compliance Report

Public Rights-of-Way

(Curb Ramps)

Intersection ID: 50905	Main Street: HELENA_PARK_LN	Cross Street: KARRAS_COMMONS_WY	Location: NE
ADA ID: 9C7C2CC3C596	Ramp Type: Perp	Initial Pass/Fail: Fail	Overall Compliance: No Severity Score: 22.5

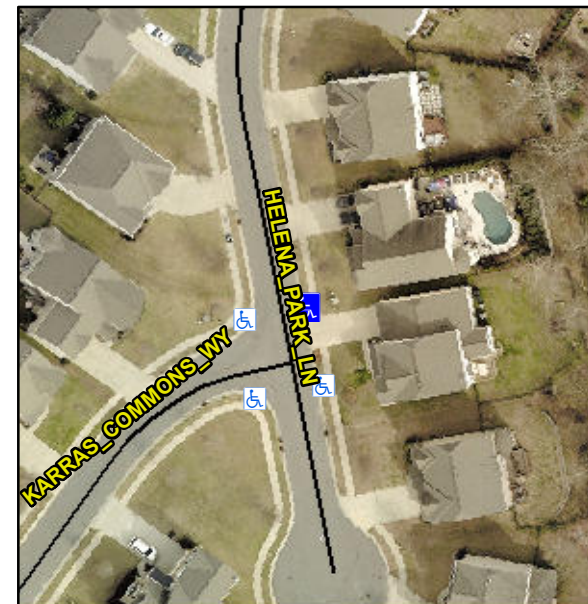
R304.5.1, R304.2.2, R304.5.3

Compliance	Description	Data	Compliance	Description	Data
N/A	Ramp Length (in)	48.0	No	Ramp Slope (%)	10.4
No	Ramp Width (in)	47.0	No	Ramp XSlope (%)	3.9
N/A	Flare Type LT	N/A	N/A	Flare Type RT	N/A
N/A	Flare Slope LT (%)	N/A	N/A	Flare Slope RT (%)	N/A
N/A	Flare Traversable LT?	N/A	N/A	Flare Traversable RT?	N/A
N/A	Landing Length (in)	N/A	N/A	DWS Provided?	N/A
N/A	Landing Width (in)	N/A	N/A	DWS Contrast?	N/A
N/A	Landing Slope (%)	N/A	N/A	DWS Length (in)	N/A
N/A	Landing X Slope (%)	N/A	N/A	DWS Full Width?	N/A
N/A	Landing Curb? (Y/N)	N/A	N/A	DWS Offset (in)	N/A
N/A	Shared Landing?	N/A			
N/A	Gutter Ponding?	N/A	N/A	Gutter Slope (%)	N/A
N/A	Gutter Lip Ht (in)	N/A	N/A	Gutter X Slope (%)	N/A
N/A	Painted X Walk1?	No	N/A	Painted X Walk2?	N/A
	X Walk 1 Direction	To W		X Walk 2 Direction	N/A
N/A	X Walk 1 Width (in)	N/A	N/A	X Walk 2 Width (in)	N/A
	X Walk 1 Slope (%)	3.1		X Walk 2 Slope (%)	N/A
	X Walk 1 X Slope (%)	1.1		X Walk 2 X Slope (%)	N/A

N/A	Ramp inside XWalk1?	N/A	N/A	Ramp inside XWalk2?	N/A
	Road Slope (%)	N/A	N/A	Clear Space?	N/A
	Road X Slope (%)	N/A	N/A	Clear Space to XWalk (in)	N/A
N/A	Any Obstructions?	N/A	N/A	Storm Grate/Utility Hazard?	N/A
	Obstruction Type			Storm Grate/Utility Type	
		N/A			N/A
			Yes	Surface Condition? (G/P)	Good

Possible Solutions:

Remove & Replace Entire Ramp.

Total Cost: \$ 1850.00
