# Access Compliance Report

## Public Rights-of-Way

### (Curb Ramps)

| Intersection ID: 10680 | Main Street: MATHESON_AV | Cross Street: PINCKNEY_AV | Location: SE |

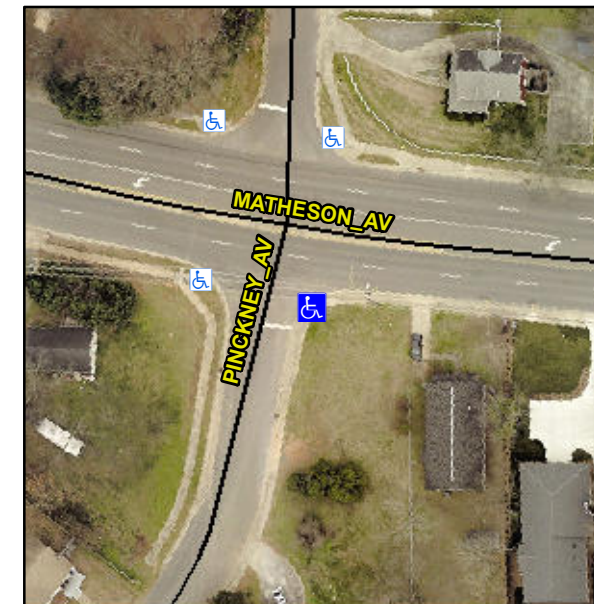
| ADA ID: 9C824CCABCD | Ramp Type: Perp | Initial Pass/Fail: Pass | Overall Compliance: No |
| | | Severity Score: 10 | |

**Not Found, R304.2.1, R304.2.2-Perp, R304.3.2-Para, R304.5.3**

| Compliance | Description | Data | Compliance | Description | Data |
|---|---|---|---|---|---|
| No | Landing Length (in) | N/A | Yes | DWS Provided? | Yes |
| No | Landing Width (in) | N/A | Yes | DWS Contrast? | Yes |
| No | Landing Slope (%) | N/A | Yes | DWS Length (in) | 24.5 |
| No | Landing X Slope (%) | N/A | Yes | DWS Full Width? | Yes |

**Remove & Replace Entire Ramp.**

Total Cost: \$ 1850.00
