Access Compliance Report

Public Rights-of-Way

(Curb Ramps)

Intersection ID: 15466	Main Street: CHARLOTTE_DR	Cross Street: LEDGEWOOD_LN	Location: NW
ADA ID: 9C88F8DD221A	Ramp Type: Directional	Initial Pass/Fail: Fail	Overall Compliance: No
Codes/Mitigation Info/Possible Solution		Field Measurements/Component Compliance	
Severity Score: 13.75

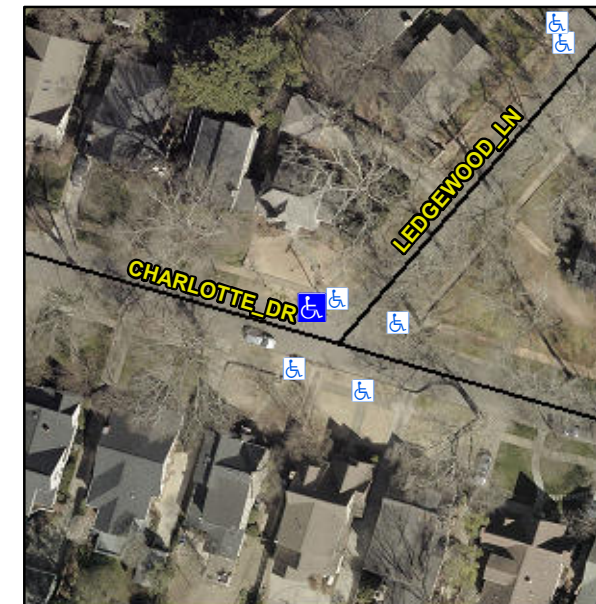
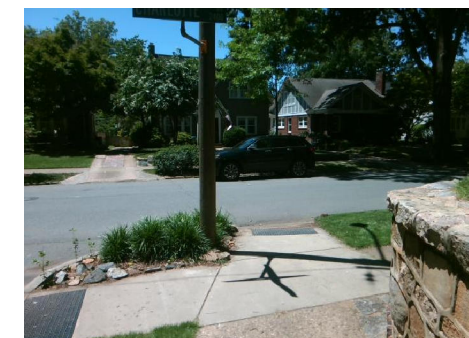
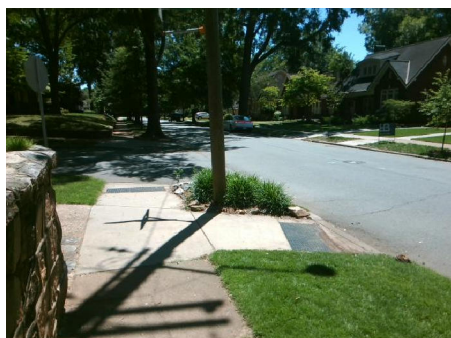
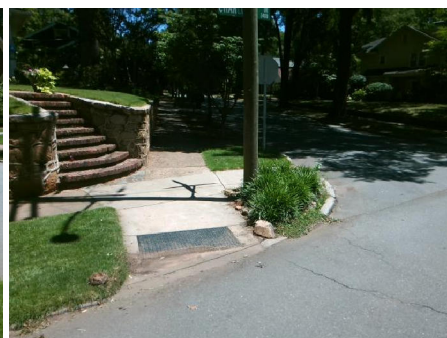
R304.2.2, R304.5.3

Compliance	Description	Data	Compliance	Description	Data
N/A	Ramp Length (in)	64.0	N/A	Grade Break?	N/A
Yes	Ramp Width (in)	66.0	N/A	Grade Break Slope (%)	0.0
No	Ramp Slope (%)	8.5	N/A	Grade Break XSlope (%)	0.0
No	Ramp XSlope (%)	2.2			
N/A	Flare Type LT	N/A	N/A	Flare Type RT	N/A
N/A	Flare Slope LT (%)	N/A	N/A	Flare Slope RT (%)	0.0
N/A	Flare Traversable LT?	N/A	N/A	Flare Traversable RT?	N/A
N/A	Landing Length (in)	0.0	N/A	DWS Provided?	N/A
N/A	Landing Width (in)	0.0	N/A	DWS Contrast?	N/A
N/A	Landing Slope (%)	0.0	N/A	DWS Length (in)	N/A
N/A	Landing X Slope (%)	0.0	N/A	DWS Full Width?	N/A
N/A	Landing Curb? (Y/N)	N/A	N/A	DWS Offset LT (in)	N/A
N/A	Shared Landing?	N/A	N/A	DWS Offset RT (in)	N/A
N/A	Gutter Ponding?	0.0	N/A	Gutter Slope (%)	N/A
N/A	Gutter Lip Ht (in)	0.0	N/A	Gutter X Slope (%)	N/A
N/A	Painted X Walk1?	No		Road Slope (%)	3.7
	X Walk 1 Direction	To S		Road X Slope (%)	1.8
	X Walk 1 Width (in)	N/A		Clear Space?	N/A

X Walk 1 Slope (%)	3.7	N/A	Clear Space to XWalk (in)	N/A
	X Walk 1 X Slope (%)	1.8	N/A	Storm Grate/Utility Hazard?	N/A
N/A	Ramp inside XWalk1?	N/A		Storm Grate/Utility Type	
N/A	Any Obstructions?	N/A			N/A
	Obstruction Type		Yes	Surface Condition? (G/P)	Good
			N/A	Curb Slope (%)	5.8

Possible Solutions:

Remove & Replace Entire Ramp.
