Access Compliance Report

Public Rights-of-Way

(Curb Ramps)

Intersection ID: N/A	Main Street: NEAL_RD	Cross Street: HATSHIRE_DR	Location: SE
ADA ID: 9C97CE39A3DD	Ramp Type: Combination1Diag	Initial Pass/Fail: Fail	Overall Compliance: No
Severity Score: 0			
Codes/Mitigation Info/Possible Solution		Field Measurements/Component Compliance

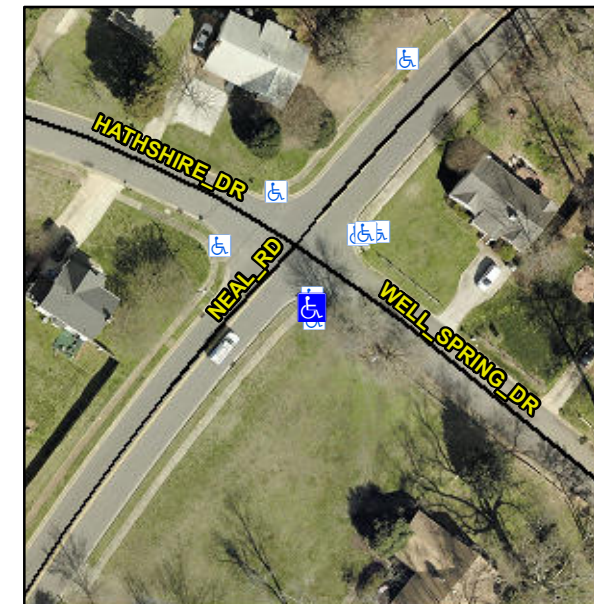
Not Found, R304.5.1, R304.5.3, R304.3.2

Compliance	Description	Data	Compliance	Description	Data
N/A	Ramp Length LT (in)	40.0	N/A	Ramp Length RT (in)	39.0
Yes	Ramp Width LT (in)	63.0	Yes	Ramp Width RT (in)	64.0
Yes	Ramp Slope LT (%)	5.0	No	Ramp Slope RT (%)	11.4
No	Ramp XSlope LT (%)	3.7	No	Ramp XSlope RT (%)	3.5
N/A	Ramp Length (in)	43.0	Yes	Ramp Slope (%)	5.7
No	Ramp Width (in)	39.0	No	Ramp XSlope (%)	3.3
N/A	Flare Type LT	N/A	N/A	Flare Type RT	N/A
N/A	Flare Slope LT (%)	N/A	N/A	Flare Slope RT (%)	N/A
N/A	Flare Traversable LT?	N/A	N/A	Flare Traversable RT?	N/A
N/A	Landing Length (in)	N/A	N/A	DWS Provided?	N/A
N/A	Landing Width (in)	N/A	N/A	DWS Contrast?	N/A
N/A	Landing Slope (%)	N/A	N/A	DWS Length (in)	N/A
N/A	Landing X Slope (%)	N/A	N/A	DWS Full Width?	N/A
N/A	Landing Curb? (Y/N)	N/A	N/A	DWS Offset (in)	N/A
N/A	Shared Landing?	N/A			
N/A	Gutter Ponding?	N/A	N/A	Gutter Slope (%)	N/A
N/A	Gutter Lip Ht (in)	N/A	N/A	Gutter X Slope (%)	N/A
N/A	Painted X Walk1?	No	N/A	Painted X Walk2?	No

X Walk 1 Direction	To NE		X Walk 2 Direction	To NW
	X Walk 1 Width (in)	N/A		X Walk 2 Width (in)	N/A
	X Walk 1 Slope (%)	2.2		X Walk 2 Slope (%)	5.7
	X Walk 1 X Slope (%)	4.2		X Walk 2 X Slope (%)	0.2
N/A	Ramp inside XWalk1?	N/A	N/A	Ramp inside XWalk2?	N/A
	Road Slope (%)	2.5		Clear Space?	N/A
	Road X Slope (%)	4.3	N/A	Clear Space to XWalk (in)	N/A
			N/A	Any Obstruction?	N/A
				Obstruction Type	N/A
			N/A	Storm Grate/Utility Hazard?	N/A
				Storm Grate/Utility Type	N/A
			Yes	Surface Condition? (G/P)	Good
				Curb Slope (%)	15.9

Possible Solutions:

Remove & Replace Curb Ramp With Two New Directional Ramps or Equivalent.
