Access Compliance Report

Public Rights-of-Way

(Curb Ramps)

Intersection ID: 6957	Main Street: N_TRYON_ST	Cross Street: N_US_29_BY-PASS_HY	Location: E
ADA ID: 9C9E972E69A2	Ramp Type: Perp	Initial Pass/Fail: Fail	Overall Compliance: No
Severity Score: 8.75			
Codes/Mitigation Info/Possible Solution		Field Measurements/Component Compliance

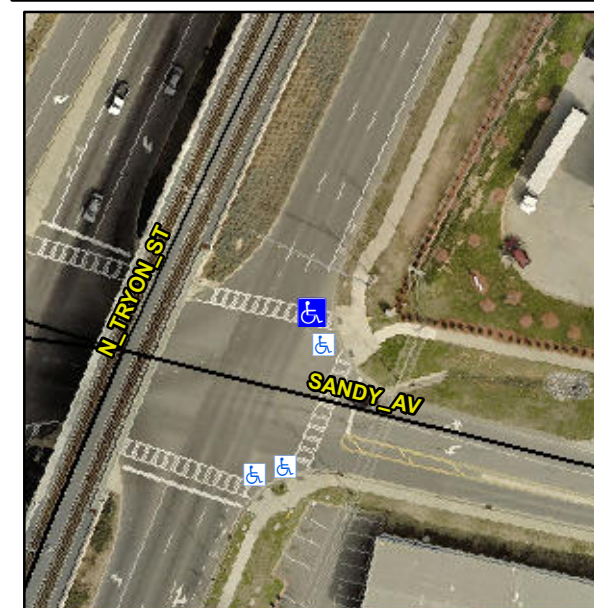
Not Found, R304.5.1

Compliance	Description	Data	Compliance	Description	Data
N/A	Ramp Length (in)	102.0	Yes	Ramp Slope (%)	6.2
No	Ramp Width (in)	46.0	Yes	Ramp XSlope (%)	1.6
N/A	Flare Type LT	N/A	N/A	Flare Type RT	N/A
N/A	Flare Slope LT (%)	N/A	N/A	Flare Slope RT (%)	N/A
N/A	Flare Traversable LT?	N/A	N/A	Flare Traversable RT?	N/A
N/A	Landing Length (in)	N/A	N/A	DWS Provided?	N/A
N/A	Landing Width (in)	N/A	N/A	DWS Contrast?	N/A
N/A	Landing Slope (%)	N/A	N/A	DWS Length (in)	N/A
N/A	Landing X Slope (%)	N/A	N/A	DWS Full Width?	N/A
N/A	Landing Curb? (Y/N)	N/A	N/A	DWS Offset (in)	N/A
N/A	Shared Landing?	N/A			
N/A	Gutter Ponding?	N/A	N/A	Gutter Slope (%)	N/A
N/A	Gutter Lip Ht (in)	1.5	N/A	Gutter X Slope (%)	N/A
N/A	Painted X Walk1?	Yes	N/A	Painted X Walk2?	N/A
	X Walk 1 Direction	To NW		X Walk 2 Direction	N/A
N/A	X Walk 1 Width (in)	111.0	N/A	X Walk 2 Width (in)	N/A
	X Walk 1 Slope (%)	5.5		X Walk 2 Slope (%)	N/A
	X Walk 1 X Slope (%)	1.0		X Walk 2 X Slope (%)	N/A

N/A	Ramp inside XWalk1?	Yes	N/A	Ramp inside XWalk2?	N/A
	Road Slope (%)	N/A	N/A	Clear Space?	N/A
	Road X Slope (%)	N/A	N/A	Clear Space to XWalk (in)	N/A
N/A	Any Obstructions?	N/A	N/A	Storm Grate/Utility Hazard?	N/A
	Obstruction Type			Storm Grate/Utility Type	
		N/A			N/A
			Yes	Surface Condition? (G/P)	Good

Possible Solutions:

Remove & Replace Entire Ramp.

Total Cost: \$ 1850.00
