Access Compliance Report Public Rights-of-Way (Curb Ramps)

Intersection ID: 9648Main Street: TIMBERBROOK_DRCross Street: TUCKASEEGEE_RDLocation: NEADA ID: 9CA2A219EEBARamp Type: ParaInitial Pass/Fail: FailOverall Compliance: NoSeverity Score: 13.75

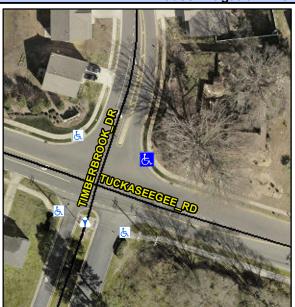
CURB LIP 0.5

Compliance Description		Data	Compliance Description		Data
N/A	Ramp Length LT (in)	58.5	N/A	Ramp Length RT (in)	54.0
Yes	Ramp Width LT (in)	59.0	Yes	Ramp Width RT (in)	59.0
Yes	Ramp Slope LT (%)	5.1	No	Ramp Slope RT (%)	9.8
No	Ramp XSlope LT (%)	2.8	No	Ramp XSlope RT (%)	2.5
N/A	Landing Length (in)	N/A	N/A	DWS Provided?	N/A
N/A	Landing Width (in)	N/A	N/A	DWS Contrast?	N/A
N/A	Landing Slope (%)	N/A	N/A	DWS Length (in)	N/A
N/A	Landing X Slope (%)	N/A	N/A	DWS Full Width?	N/A
N/A	Landing Curb? (Y/N)	N/A	N/A	DWS Offset (in)	N/A
N/A	Shared Landing?	N/A			
N/A	Gutter Ponding?	N/A	N/A	Gutter Slope (%)	N/A
N/A	Gutter Lip Ht (in)	N/A	N/A	Gutter X Slope (%)	N/A
N/A	Painted X Walk1?	No	N/A	Painted X Walk2?	N/A
	X Walk 1 Direction	To W		X Walk 2 Direction	N/A
N/A	X Walk 1 Width (in)	N/A	N/A	X Walk 2 Width (in)	N/A
	X Walk 1 Slope (%)	0.3		X Walk 2 Slope (%)	N/A
	X Walk 1 X Slope (%)	0.1		X Walk 2 X Slope (%)	N/A
N/A	Ramp inside XWalk1?	N/A	N/A	Ramp inside XWalk2?	N/A

Road Slope (%)	N/A	N/A	Clear Space?	N/A
	Road X Slope (%)	N/A	N/A	Clear Space to XWalk (in)	N/A
N/A	Any Obstructions?	N/A	N/A	Storm Grate/Utility Hazard?	N/A
	Obstruction Type			Storm Grate/Utility Type	
		N/A			N/A
			Yes	Surface Condition? (G/P)	Good
			N/A	Curb Slope (%)	6.9

Remove & Replace Entire Ramp.

R304.5.3, R304.3.2

Total Cost: \$ 1600.00
