Access Compliance Report

Public Rights-of-Way

(Curb Ramps)

Intersection ID: 31510	Main Street: GRIER_SPRINGS_LN	Cross Street: CONNELL_GREEN_DR	Location: NW
ADA ID: 9CA582B81C2C	Ramp Type: BlendTrans1	Initial Pass/Fail: Fail	Overall Compliance: No
			Severity Score: 21.25

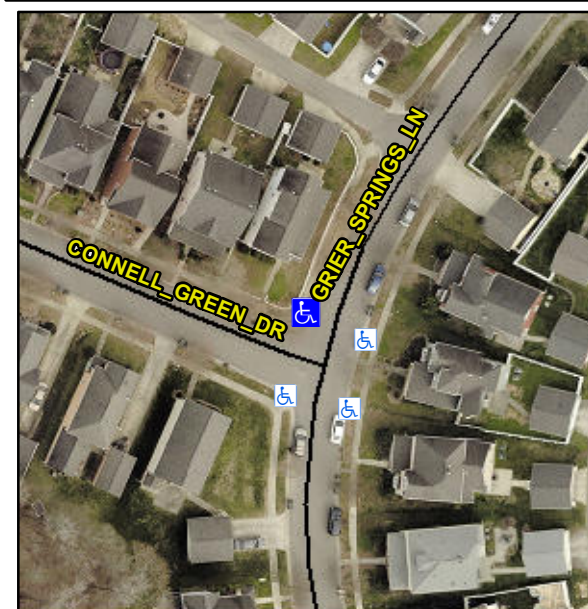
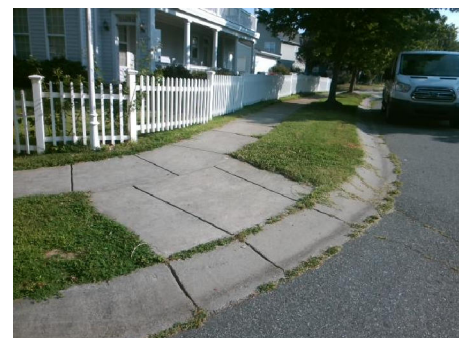
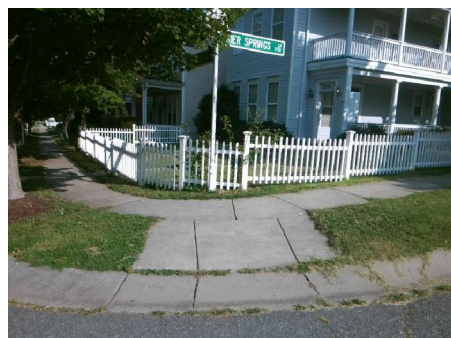
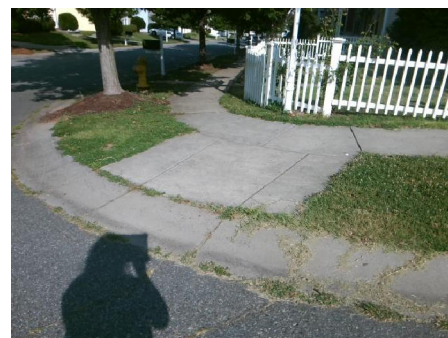
Compliance	Description	Data	Compliance	Description	Data
N/A	Ramp Length (in)	62.5	Yes	BlendTrans Slope (%)	4.7
No	Ramp Width (in)	40.0	No	BlendTrans XSlope (%)	6.2
N/A	Flare Type LT	N/A	N/A	Flare Type RT	N/A
N/A	Flare Slope LT (%)	N/A	N/A	Flare Slope RT (%)	N/A
N/A	Flare Traversable LT?	N/A	N/A	Flare Traversable RT?	N/A
N/A	Landing Length (in)	N/A	N/A	DWS Provided?	N/A
N/A	Landing Width (in)	N/A	N/A	DWS Contrast?	N/A
N/A	Landing Slope (%)	N/A	N/A	DWS Length (in)	N/A
N/A	Landing X Slope (%)	N/A	N/A	DWS Full Width?	N/A
N/A	Landing Curb? (Y/N)	N/A	N/A	DWS Offset (in)	N/A
N/A	Shared Landing?	N/A			
N/A	Gutter Ponding?	N/A	N/A	Gutter Slope (%)	N/A
N/A	Gutter Lip Ht (in)	N/A	N/A	Gutter X Slope (%)	N/A
N/A	Painted X Walk1?	No	N/A	Painted X Walk2?	No
	X Walk 1 Direction	To SW		X Walk 2 Direction	To SE
	X Walk 1 Width (in)	N/A		X Walk 2 Width (in)	N/A
	X Walk 1 Slope (%)	2.2		X Walk 2 Slope (%)	7.9
	X Walk 1 X Slope (%)	8.4		X Walk 2 X Slope (%)	2.4

N/A	Ramp inside XWalk1?	N/A	N/A	Ramp inside XWalk2?	N/A
	Road Slope (%)	5.8		Clear Space?	N/A
	Road X Slope (%)	5.3	N/A	Clear Space to XWalk (in)	N/A
N/A	Any Obstructions?	N/A	N/A	Storm Grate/Utility Hazard?	N/A
	Obstruction Type			Storm Grate/Utility Type	
		N/A			N/A
			Yes	Surface Condition? (G/P)	Good
			N/A	Curb Slope (%)	N/A

Possible Solutions:

Remove & Replace Curb Ramp With Two New Directional Ramps or Equivalent.

R304.5.1, R304.5.3

Total Cost: \$ **3200.00**
