# Access Compliance Report

## Public Rights-of-Way

### (Curb Ramps)

Intersection ID: 11891	Main Street: N_POPLAR_ST	Cross Street: W_6TH_ST	Location: W
ADA ID: 9CCA33CCE255	Ramp Type: PerpDiag	Initial Pass/Fail: Pass	Overall Compliance: No
			Severity Score: 10.25

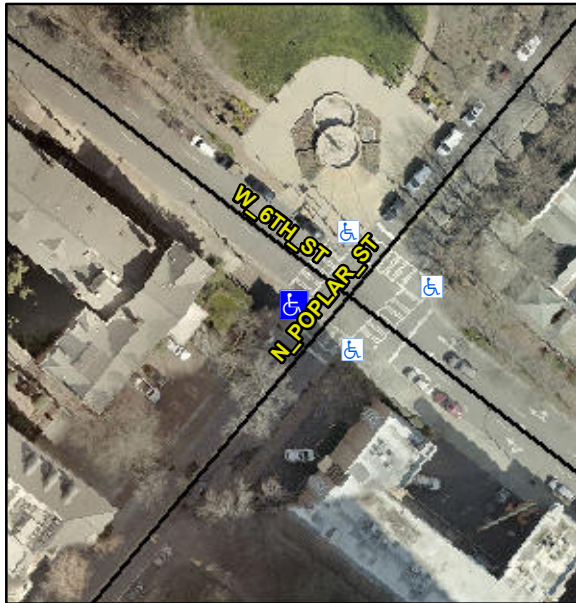
**Not Found, R304.5.3, R305**

Compliance	Description	Data	Compliance	Description	Data
N/A	Ramp Length (in)	104.0	Yes	Ramp Slope (%)	6.6
Yes	Ramp Width (in)	49.0	No	Ramp XSlope (%)	3.3
N/A	Flare Type LT	Sloped	N/A	Flare Type RT	N/A
N/A	Flare Slope LT (%)	7.3	Yes	Flare Slope RT (%)	2.8
N/A	Flare Traversable LT?	Yes	N/A	Flare Traversable RT?	Yes
Yes	Landing Length (in)	60.0	No	DWS Provided?	No
Yes	Landing Width (in)	60.0	N/A	DWS Contrast?	No
Yes	Landing Slope (%)	1.2	N/A	DWS Length (in)	N/A
No	Landing X Slope (%)	4.3	N/A	DWS Full Width?	No
N/A	Landing Curb? (Y/N)	No	N/A	DWS Offset (in)	N/A
N/A	Shared Landing?	No			
Yes	Gutter Ponding?	No	Yes	Gutter Slope (%)	1.9
Yes	Gutter Lip Ht (in)	0.0	No	Gutter X Slope (%)	2.5
N/A	Painted X Walk1?	Yes	N/A	Painted X Walk2?	Yes
	X Walk 1 Direction	To SE		X Walk 2 Direction	To NE
N/A	X Walk 1 Width (in)	137.0	N/A	X Walk 2 Width (in)	137.0
	X Walk 1 Slope (%)	1.0		X Walk 2 Slope (%)	1.0
	X Walk 1 X Slope (%)	3.7		X Walk 2 X Slope (%)	1.0

Yes	Ramp inside XWalk1?	Yes	Yes	Ramp inside XWalk2?	Yes
	Road Slope (%)	0.2	N/A	Clear Space?	Yes
	Road X Slope (%)	3.2	No	Clear Space to XWalk (in)	N/A
Yes	Any Obstructions?	No	Yes	Storm Grate/Utility Hazard?	No
	Obstruction Type			Storm Grate/Utility Type	
		N/A			N/A
			Yes	Surface Condition? (G/P)	Good

**Remove & Replace Curb Ramp With Two New Directional Ramps or Equivalent. Restripe Crosswalk(s) To Provide Clear space. Remove & Replace Gutter.**
