## Access Compliance Report Public Rights-of-Way (Curb Ramps)

Intersection ID: 11231 Main Street: W\_4TH\_ST\_EXT Cross Street: WALNUT\_AV Location: NE

ADA ID: 9CD61343FC6F Ramp Type: Perp Initial Pass/Fail: Fail Overall Compliance: No Severity Score: 12.5

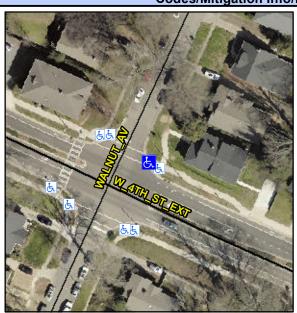
Comp	liance Description	Data	Comp	liance	Description	Data
N/A	Ramp Length (in)	100.0	No	Ramp	Slope (%)	8.4
Yes	Ramp Width (in)	69.5	Yes	Ramp	XSlope (%)	1.2
N/A	Flare Type LT	N/A	N/A	Flare	Type RT	N/A
N/A	Flare Slope LT (%)	N/A	N/A	Flare	Slope RT (%)	N/A
N/A	Flare Traversable LT?	N/A	N/A	Flare	Traversable RT?	N/A
N/A	Landing Length (in)	N/A	N/A	DWS	Provided?	N/A
N/A	Landing Width (in)	N/A	N/A	DWS	Contrast?	N/A
N/A	Landing Slope (%)	N/A	N/A	DWS	Length (in)	N/A
N/A	Landing X Slope (%)	N/A	N/A	DWS	Full Width?	N/A
N/A	Landing Curb? (Y/N)	N/A	N/A	DWS	Offset (in)	N/A
N/A	Shared Landing?	N/A				
N/A	Gutter Ponding?	N/A	N/A	Gutte	r Slope (%)	N/A
N/A	Gutter Lip Ht (in)	N/A	N/A	Gutte	r X Slope (%)	N/A
N/A	Painted X Walk1?	No	N/A	Paint	ed X Walk2?	N/A
	X Walk 1 Direction	To NW		X Wa	lk 2 Direction	N/A
N/A	X Walk 1 Width (in)	N/A	N/A	X Wa	lk 2 Width (in)	N/A
	X Walk 1 Slope (%)	1.4		X Wa	lk 2 Slope (%)	N/A
	X Walk 1 X Slope (%)	4.3		X Wa	lk 2 X Slope (%)	N/A

N/A	Ramp inside XWalk1?	N/A	N/A	Ram	inside XWalk2?	N/A
	Road Slope (%)	N/A	N/A	Clear	Space?	N/A
	Road X Slope (%)	N/A	N/A	Clear	Space to XWalk (in)	N/A
N/A	Any Obstructions?	N/A	N/A	Storn	n Grate/Utility Hazard?	N/A
	Obstruction Type			Storn	n Grate/Utility Type	
		N/A				N/A
			Yes	Surfa	ce Condition? (G/P)	Good

-	Possible Solutions:
100	Remove & Replace Entire Ramp.
	Surveyor Notes:
-	N/A
1	PROW/ADA:
	R304.2.2
1	
- Charles
