# Access Compliance Report

## Public Rights-of-Way

### (Curb Ramps)

| Intersection ID: 16634 | Main Street: OLD_PINEVILLE_RD | Cross Street: YANCEY_RD | Location: SW |

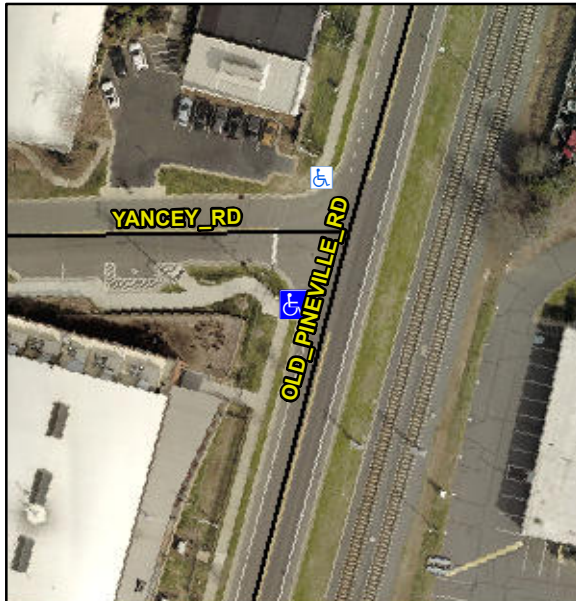
**Not Found, R304.2.2-Perp, R304.3.2-Para**

| Compliance | Description | Data | Compliance | Description | Data |
|---|---|---|---|---|---|
| No | Landing Slope (%) | 2.8 | Yes | DWS Length (in) | 24.0 |

Possible Solutions:

**Remove & Replace Curb Ramp With Two New Directional Ramps or Equivalent.**

Total Cost: \$ 3200.00

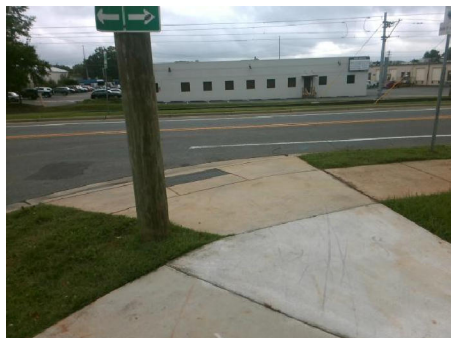
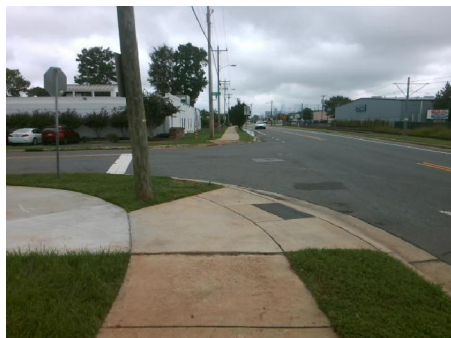
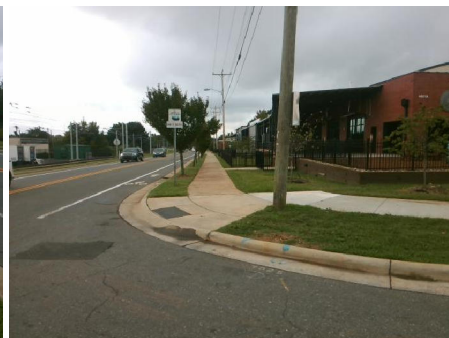
Street 1 Name OLD PINEVILLE RD  
 Stop Condition-Street 2 None  
 Street 2 Name YANCEY RD  
 Stop Condition-Street 1 StopSign
